# PROPERTY INSPECTION REPORT

**12/11/2023**

**Dallas, TX  
75244**

**Inspector: Brian Wharton**

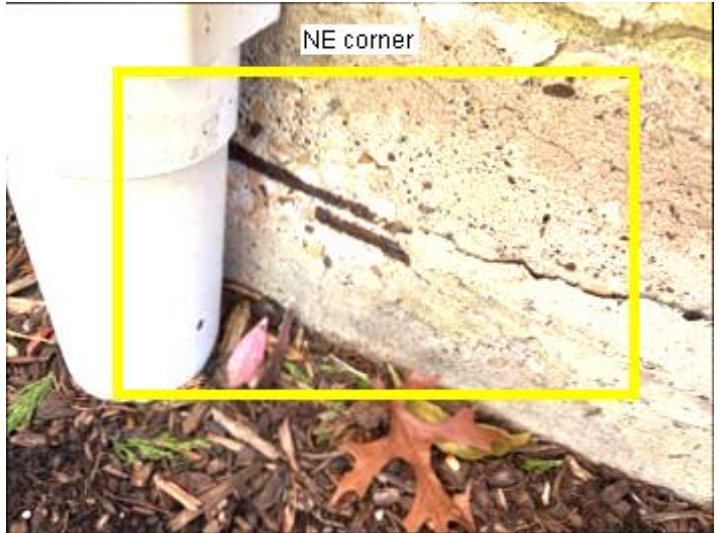
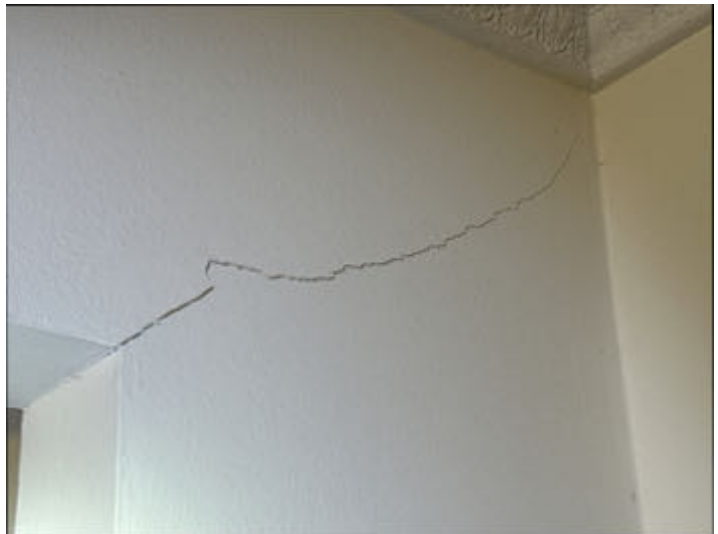
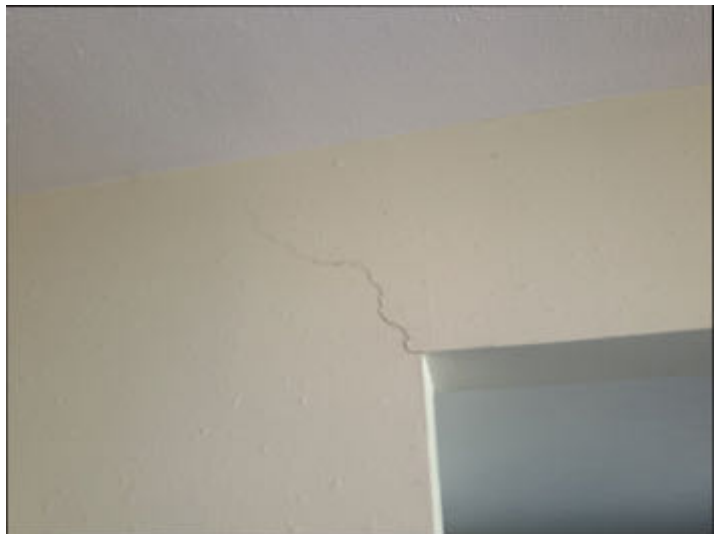
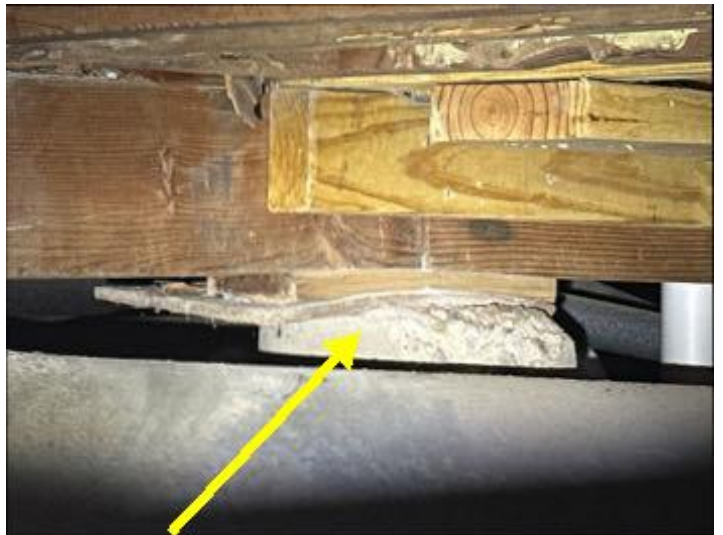
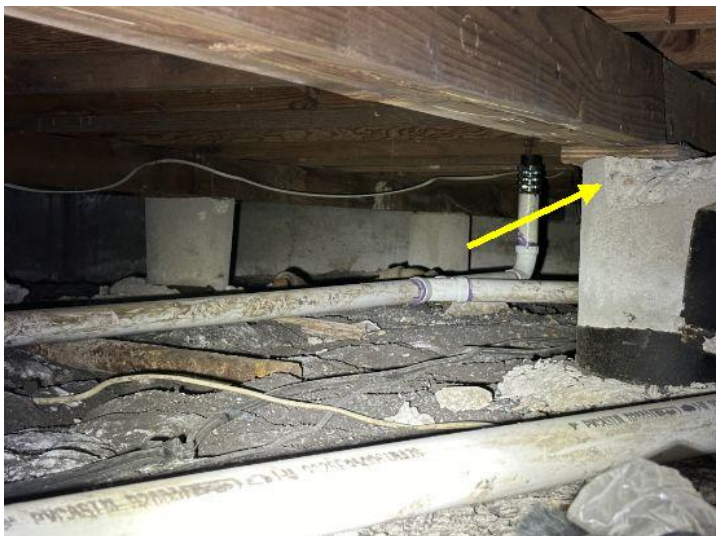
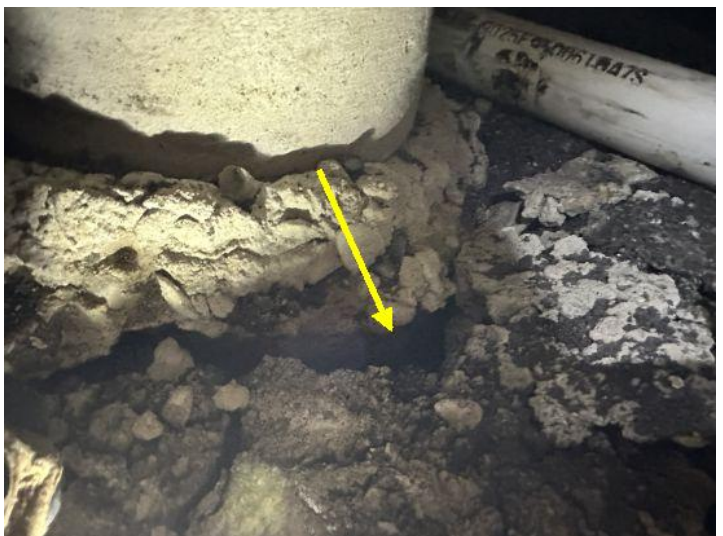
Spalling and horizontal cracking noted at back of house and at NE corner.

Exposed rebar noted at NE corner of house

Split cement pillars noted.

Wood supports that had direct contact with th ground noted.

Warped shims and off center pillars noted.

Evidence of excessive water noted in crawlspace.

No vapor barrier or underfloor insulation noted.

Possible mold noted in crawlspace

Recommend review by qualified foundation expert.

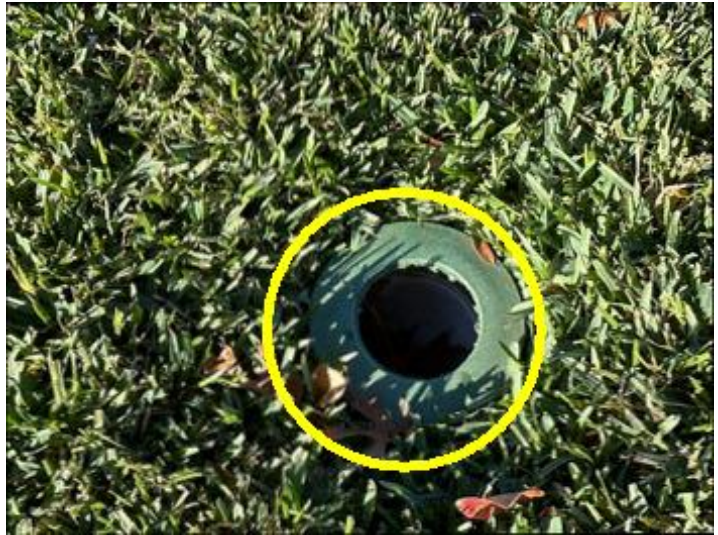
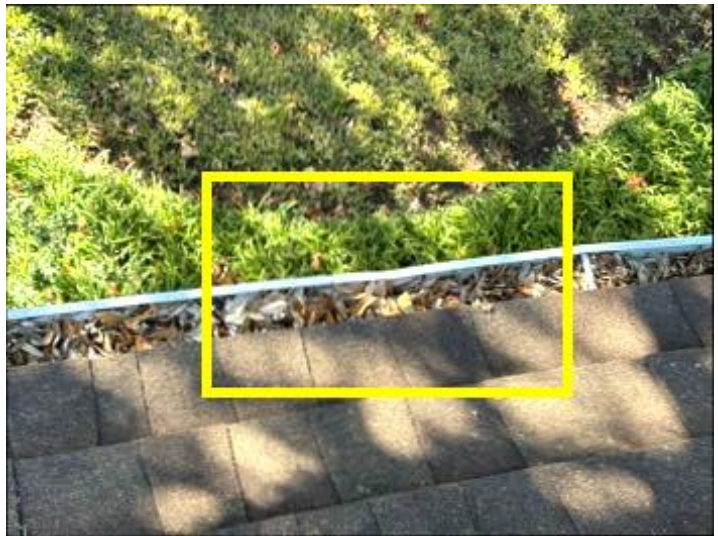
- The gutter system was partially blocked with debris and one or more downspouts or splash blocks were in need of repair

Downspout extension too short

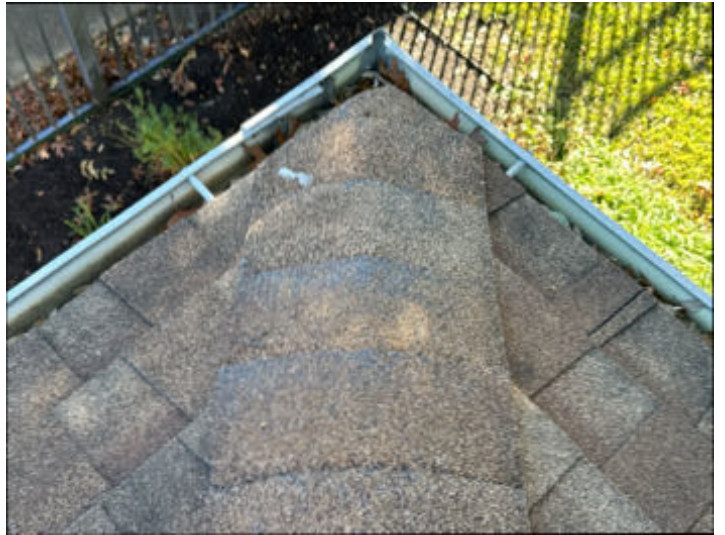
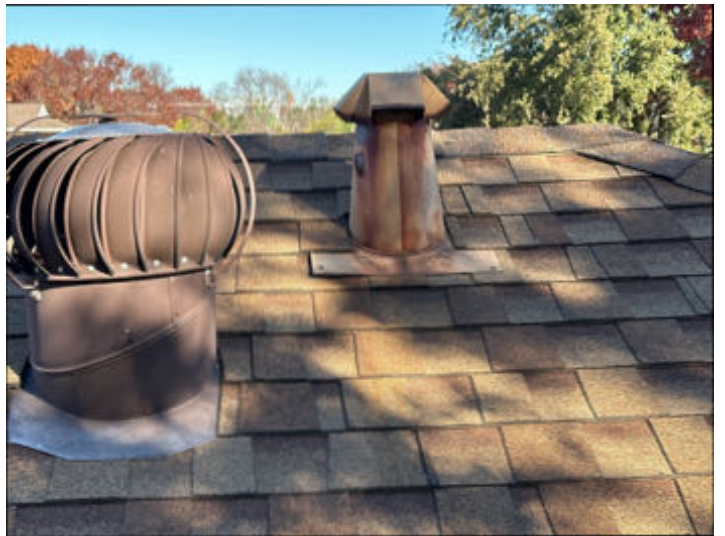
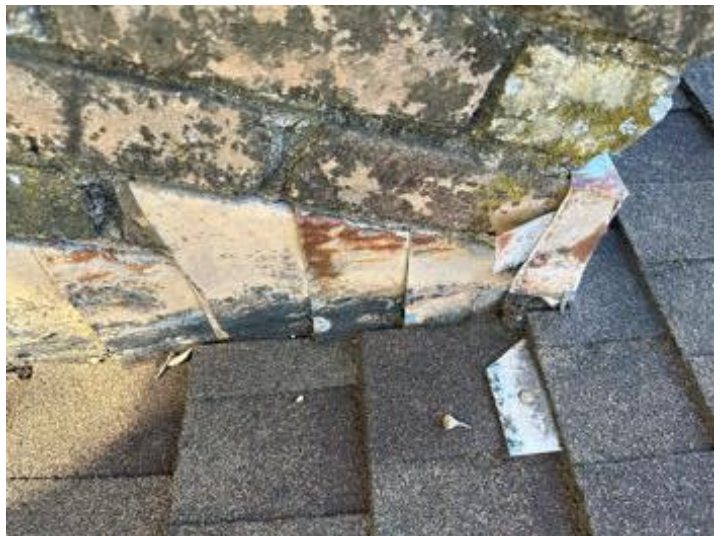
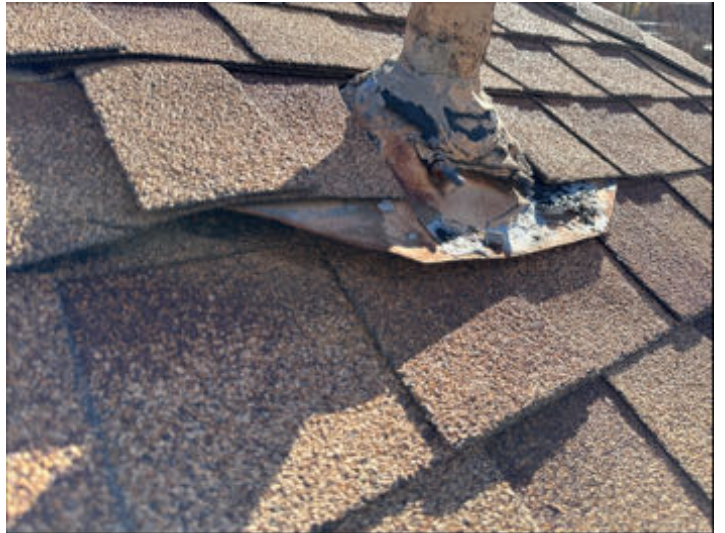
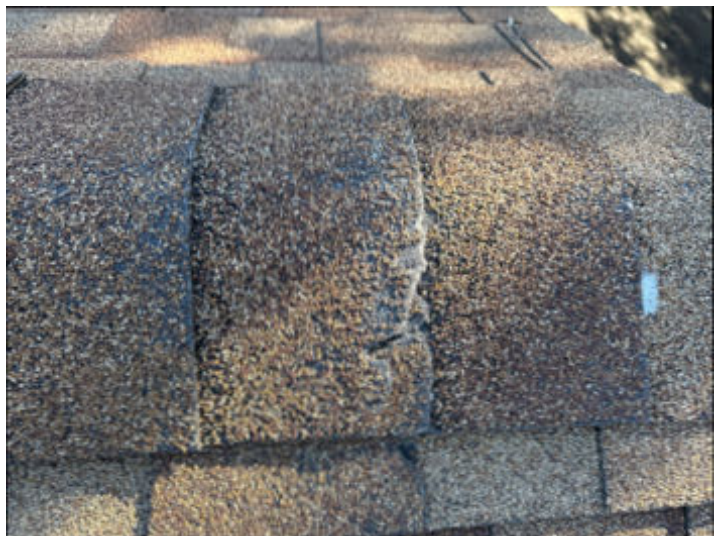
- The roofing materials were severely deteriorated and well beyond their lifespan. Recommend replacement of the roof materials by a qualified roofing contractor to avoid leaks (or additional damage from leaks: see Ceilings and Floors section and Roof Structure and Attics sections).

- Flashing material was observed to be missing and/or damaged in some areas of the roof and/or chimney base area

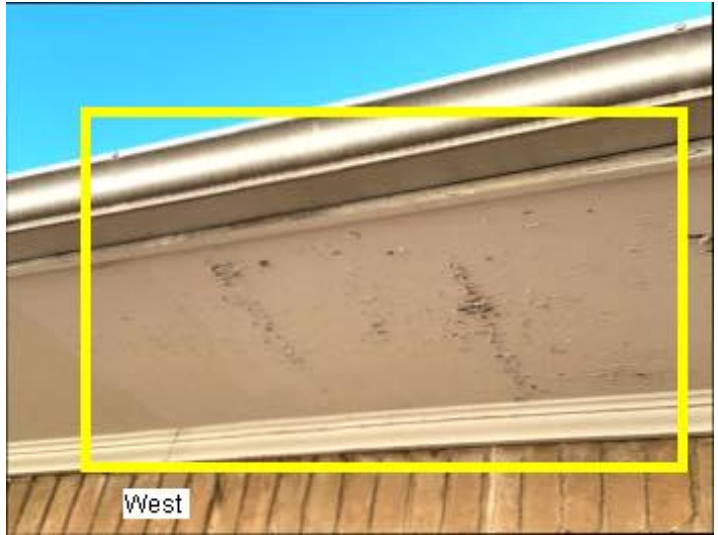
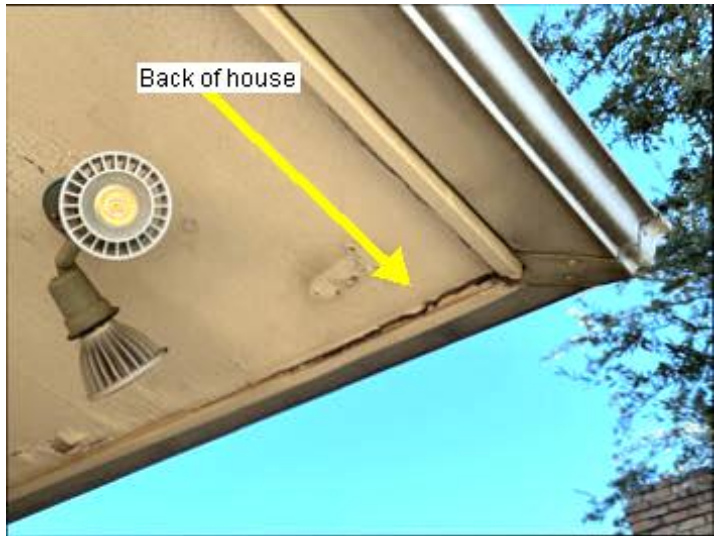
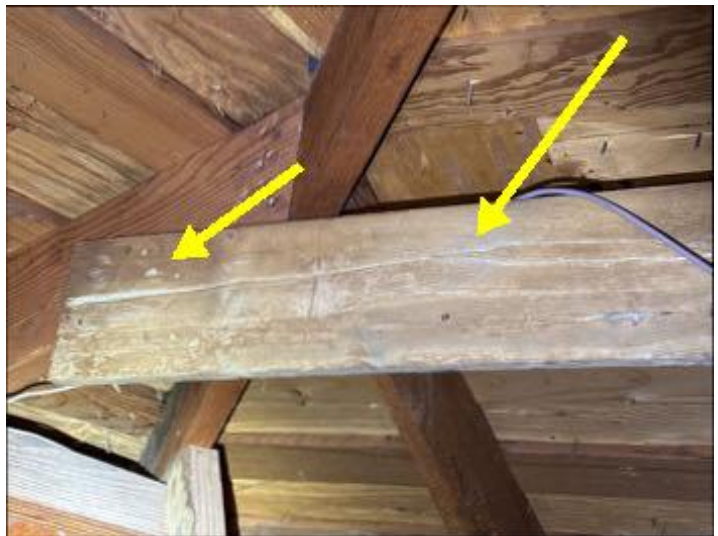
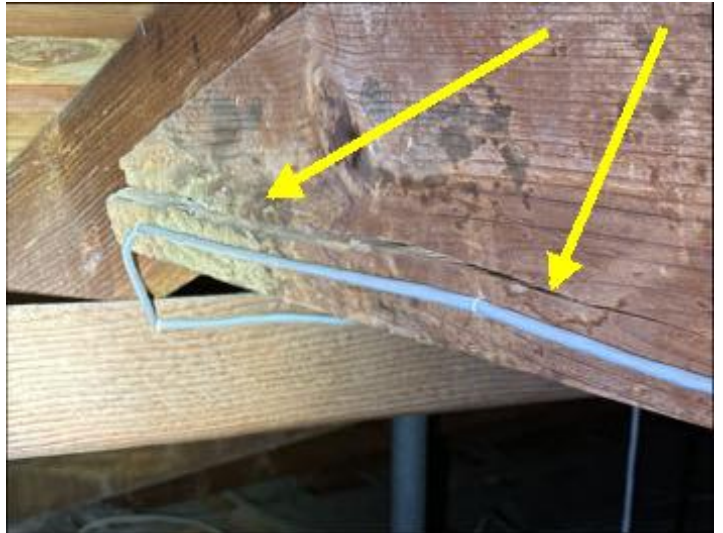
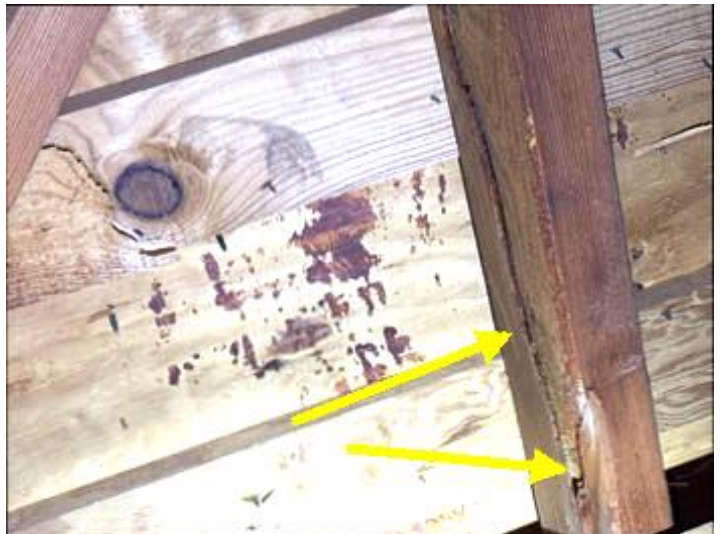
- Roofing system is deficient.
- The fascia board has some deterioration on more than one location on the structure
- The soffit material is sagging and/or pulling loose on one or more locations on the roof structure
- The attic insulation was observed to be covering the recessed lighting fixtures and should be removed from these areas to prevent overheating
- Evidence of roof rafters bowing / cracking.
- Split and/or broken framing members observed and should be corrected

NOTE: EXPOSED WIRING IN ATTIC IS A SAFETY CONCERN. RECOMMEND CORRECTION BY LICENSED ELECTRICIAN.

- Recommend adding insulation in the attic space(s) to achieve a consistent total depth of at least 16 inches (the current standard). This will provide improved energy efficiency and cost savings. Levels could be more depending on the insulation material used.

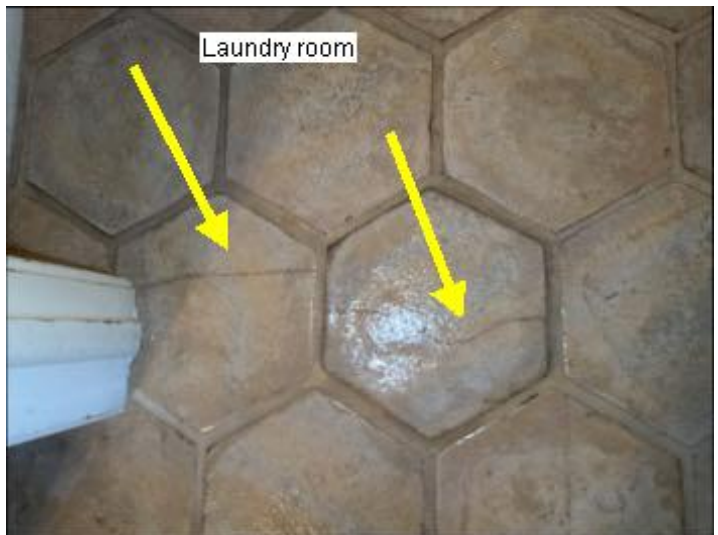
- Cracked tiles noted in kitchen and laundry room

Water stain on ceiling in front family room.

Cracks in walls and ceilings in garage.

Cracked and separating floor joists noted in crawlspace.

Possible WDI damaged floor joists noted in crawlspace.

Cracks in ceiling in sitting area by fireplace and in south bedroom ceiling.

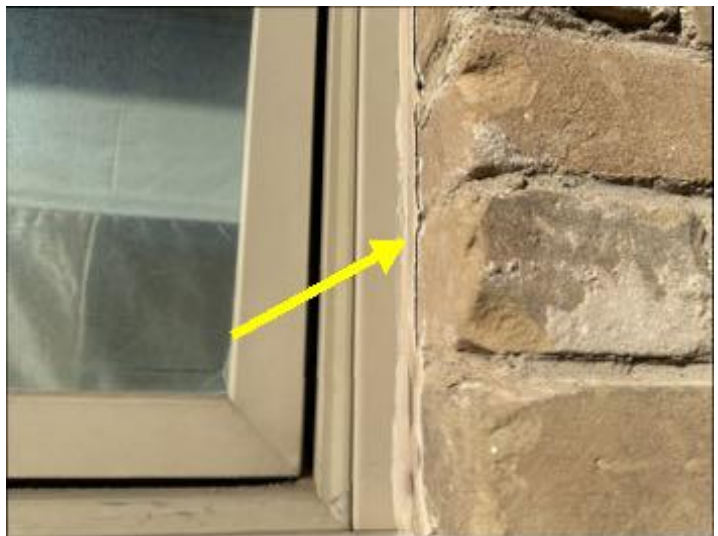
- One or more of the thermal pane windows were observed to have lost their seals. This has resulted in condensation or a fog like film to develop between the panes of glass. The thermal pane windows are no longer functional as designed when the seal is lost and replacement may be necessary

- Weather stripping and/or glazing was either damaged and/or missing at one or more windows

- Some of the windows were difficult to get opened, closed and/or locked. Lubrication, exercise and adjustment is recommended. Noted throughout.

Apparent frame damage noted on windows off of dining room

NOTE: had to exit house and manually close window from outside due to improper ability for casement window to "catch" window and close it to be locked.

Recommend review of all windows by qualified specialist.

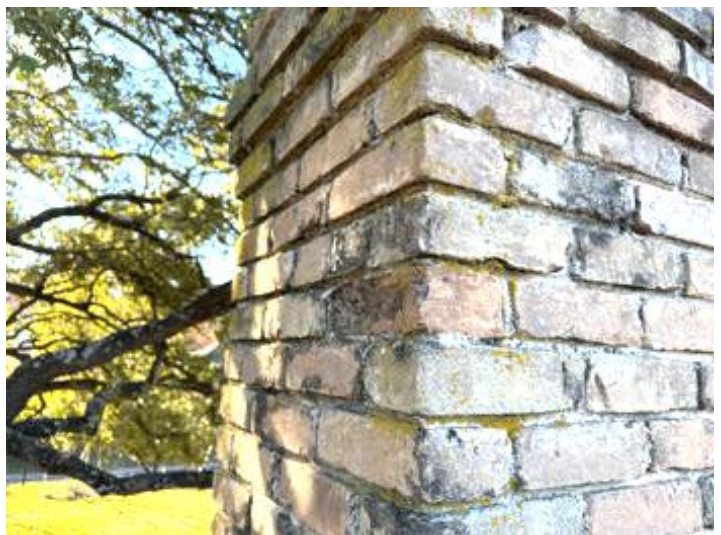
- Spalling brick was observed on the chimney(s). This is often caused by moisture getting behind the surface of the brick. While usually cosmetic, any areas of deteriorated mortar or caulking should be properly repaired before any bricks are replaced.

- It was observed that masonry cracks were present within the firebox and is in need of corrective action

Gas line into firebox appeared to be broken and end of life.  
NOT tested by inspector.

- Excessive build-up of soot or creosote was observed in the flue(s) and/or fireplace(s). Creosote is a fire hazard. Cleaning and inspection by a qualified chimney sweep is recommended. Flue or firebox defects may be hidden by soot and creosote.

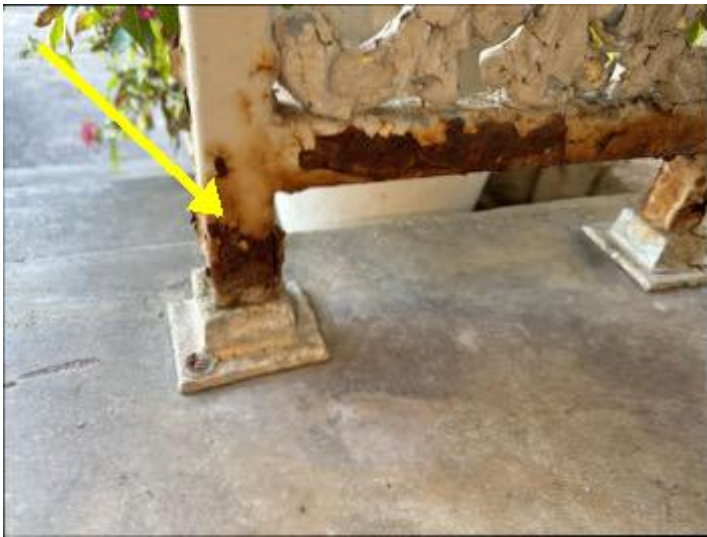
- Front rail at stairs is loose.

Front ornamental metal porch columns are rusted and end of life.

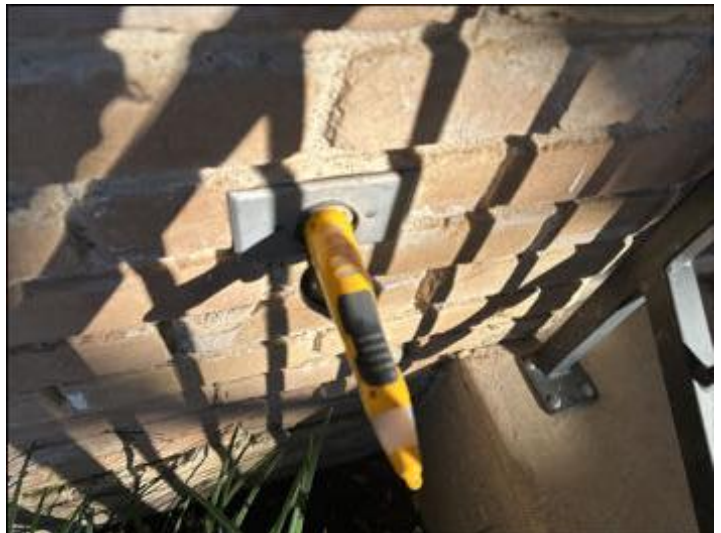
- Open wire splices were observed. This is hazardous because the metal conductors can be exposed or may be pulled apart. Recommend further review and correction of all open splices (into proper junction boxes) by a qualified electrician. >Open Splice Location(s) NOTED in attic and in crawlspace

- One or more electrical outlets did not appear to be "grounded" when tested. Grounding provides an emergency path for electricity and helps to prevent electrical shock. Recommend further review by a qualified electrician to determine cause and options for correction of the open ground conditions  
NOTED outside and in bathrooms with GFCI's  
NOTE: RENDERS GFCI OUTLET SAFETY FEATURES USELESS.

NOTE overheated outlet noted in laundry room closet.

- Open junction boxes were observed. Recommend all junction boxes have proper covers installed for personal safety. Open Junction Box Location(s): NOTED in attic and crawlspace. THIS IS A SAFETY CONCERN.

Loose outlet cover for furnace on off switch in hall closet.

**RECOMMEND REVIEW OF ELECTRIC SYSTEM BY LICENSED ELECTRICIAN.**

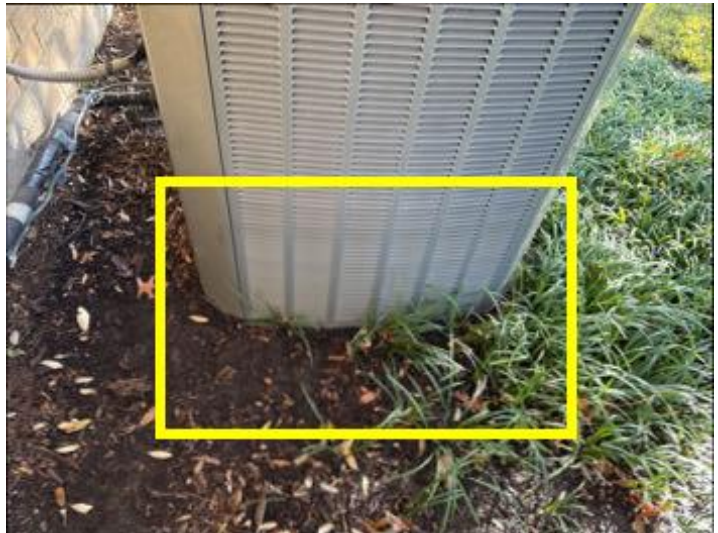
- The unit appeared to be cooling inadequately when the temperature drop was measured across the system. Poor cooling can be caused by several possible deficiencies and further review and correction by a qualified heating contractor is recommended. The normal operating range tested is between 15 and 22 degrees. This unit achieved 11 degrees differential.

- The breaker providing protection and electric service to the air conditioning unit at the contractor cut off by the unit appears to be too large. The system appears to call for a max breaker size of 45amps but the cut off is rated for 60 amps.

Recommend service and review of system by licensed HVAC professional.

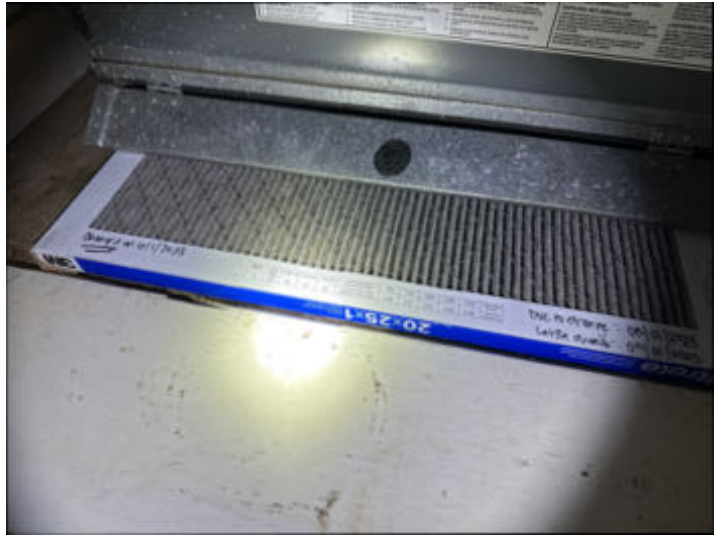
- Duct work should be suspended and not take hard turns to avoid crimping
- The air filter(s) was dirty at the time of the inspection. Dirty filters restrict air flow which may cause short cycling and can shorten the life of the heating equipment. Recommend changing (or cleaning, if a reusable type) the filter in accordance with the filter manufacturer's and the heating equipment manufacturer's directions.
- Registers are dirty

Sampling of substance on registers taken and will be included in mold report  
Inspector holds Texas Mold License TDLR MAT1313.

Recommend review of by licensed HVAC professional.

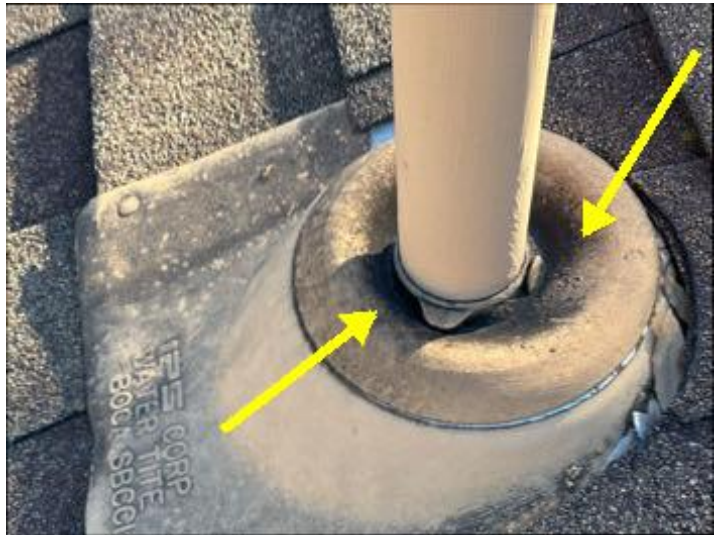
Rubber plumbing stack boot jacks are depressed and will eventually fail and cause water leaks,.

Recommend review of all concerns by licensed plumber.

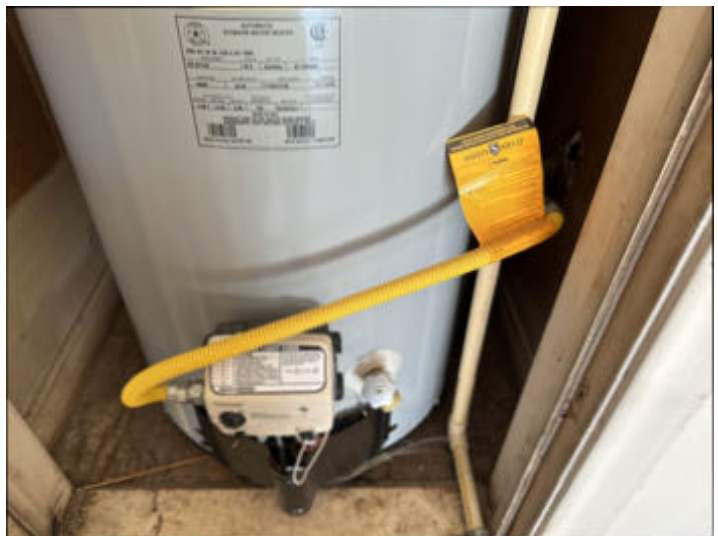
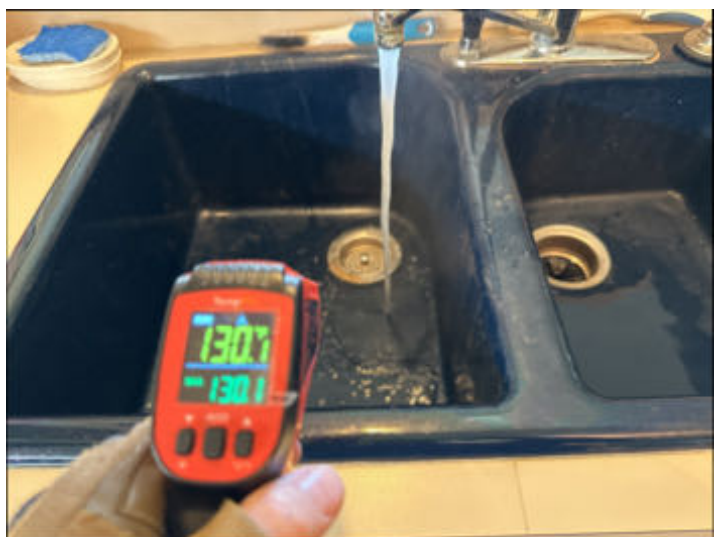
- The TPR valve drain pipe was not terminated on the exterior and is a Safety Hazard
- It was noted that the water heater was not equipped with a corrosion resistant drain pan to discharge on the exterior
- Sediment trap missing from water heater
- The water temperature at the faucet locations was noted to exceed the {120 degree} scald limit and adjustments on the temperature control are recommended

Recommend review of all concerns by licensed plumber.

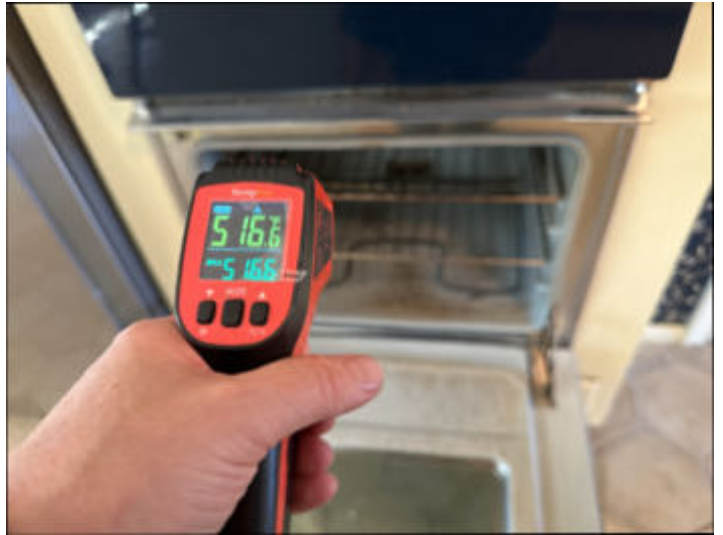
- Oven(s)/cooktop: Electric
- Cooktop appeared to work as intend.
- Bottom oven appeared to have deficient temperature setting as the oven was set at 350 degrees and reached over 500 degrees.

Recommend review by licensed appliance contractor.

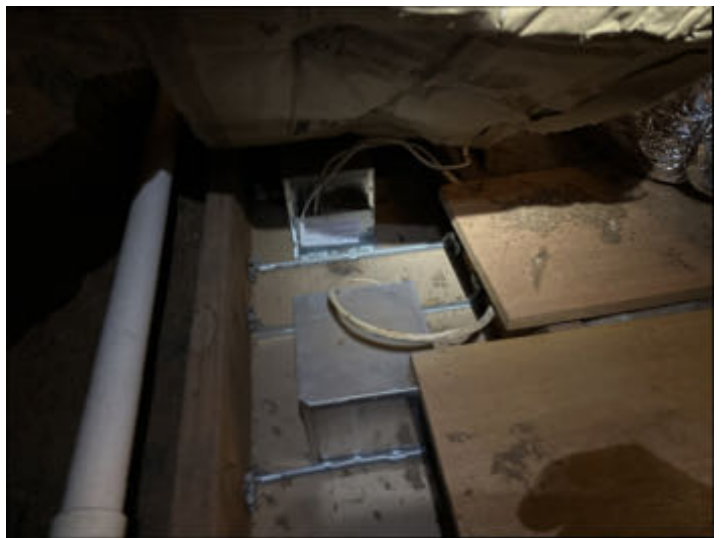
- The vent fan terminated in the attic space and should be vented to the exterior as per current building standards

Bath fan over shower enclosure in hall bath - need to review with seller to review installation manual to ensure that this unit is rated for placement over the shower and not next to it (unit must be properly moisture rated).
