The BrickKicker

Phase Inspection Report

Texas Pistache Dr, Dallas, TX
Inspection prepared for:
Real Estate Agent: -

Date of Inspection: 10/30/2021 Time: 8:00 AM
Age of Home: 2021 Size: 3000
Order ID: 635

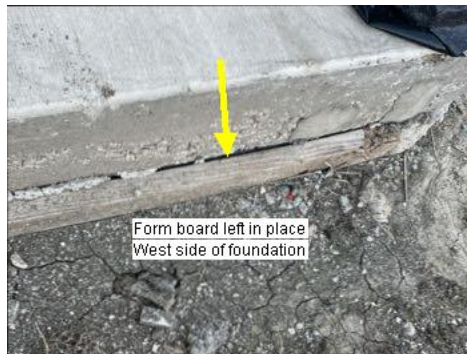
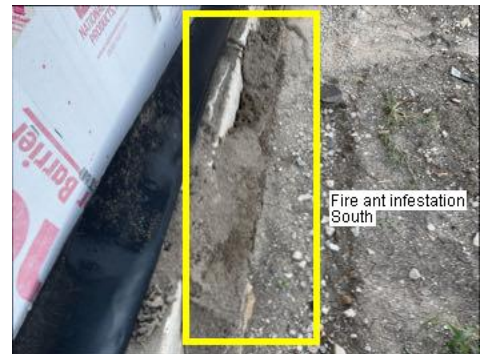
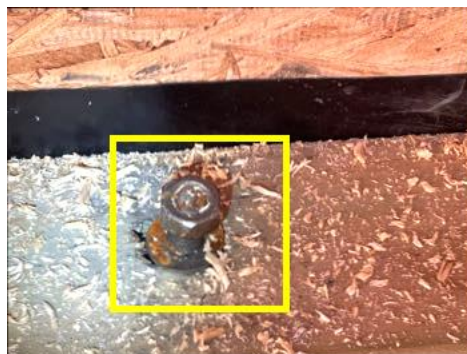
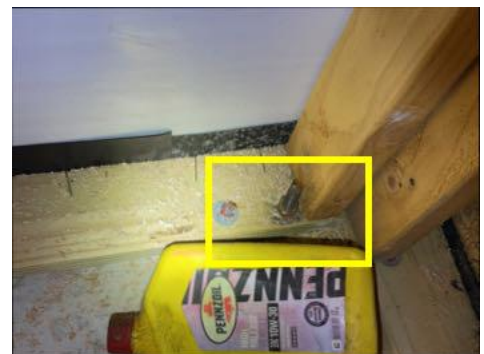
Wood form boards were left in place and were in contact with the foundation. We recommend having them removed to prevent creating conducive conditions for wood destroying insect activity.

A sill plate had been cut/was damaged. We recommend having this repaired per structural engineer's instructions.

A loose anchor bolt was observed at a sill plate. We recommend having this secured prior to hanging the sheetrock.

Anchor bolts off center and not properly fastened

Fore ant infestation

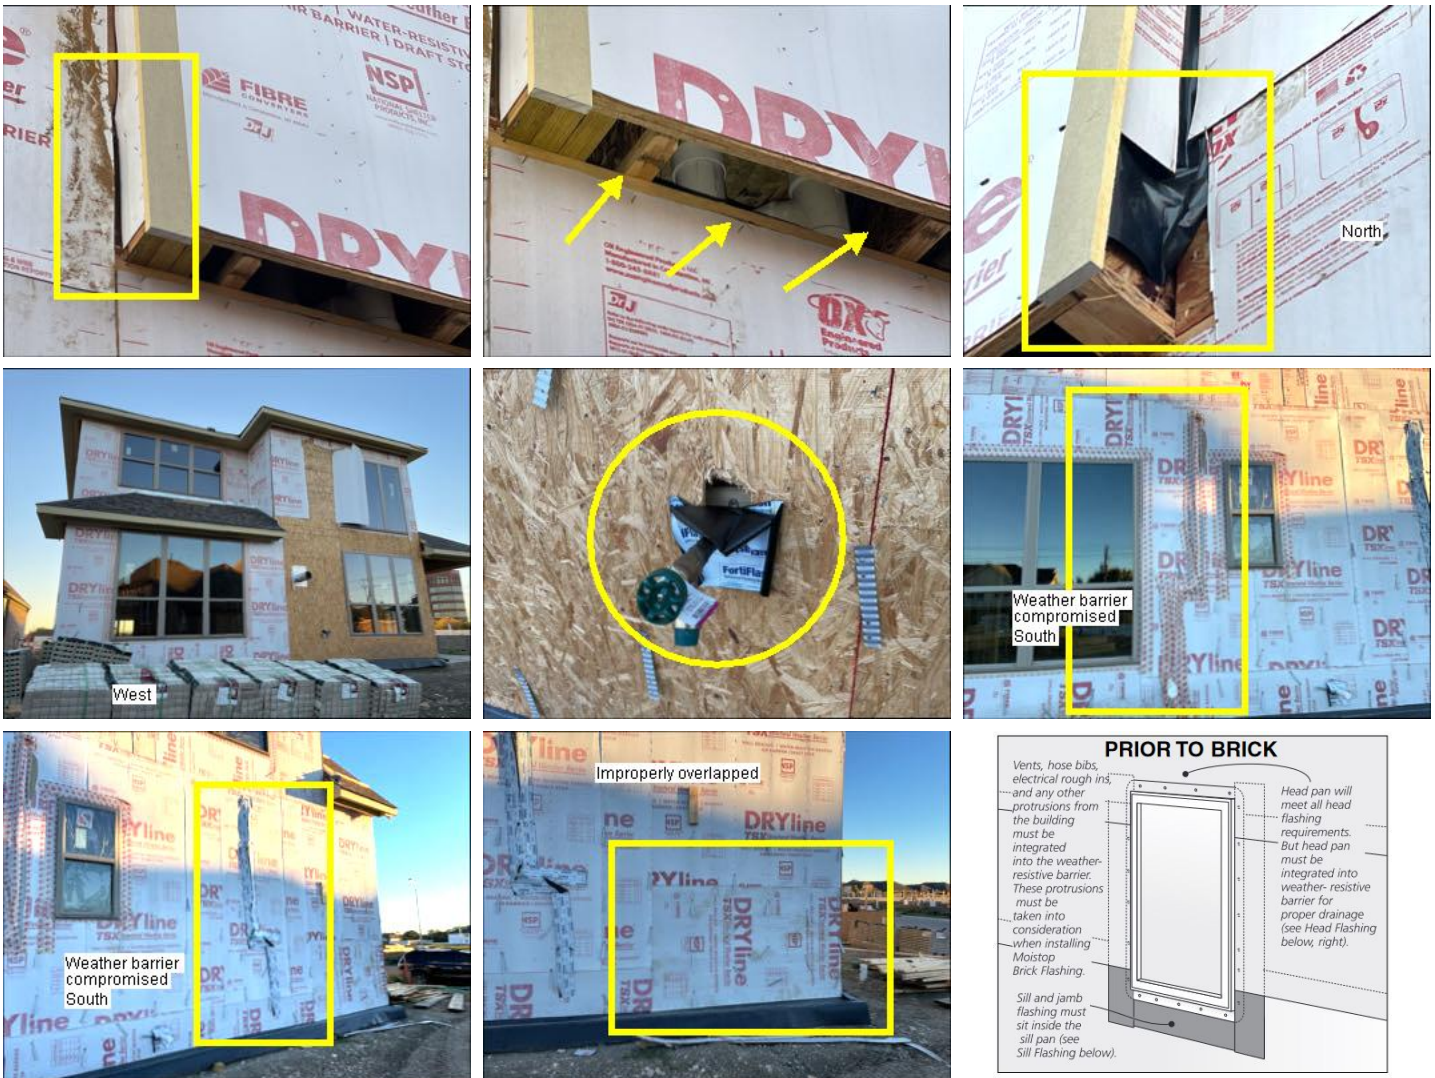
Holes/tears were observed in the weather resistive barrier. We recommend having them repaired per the manufacturer's instruction.

Tape flashing was missing over/around a window. We recommend having this added per manufacturer's instructions to prevent potential moisture intrusion.

The weather resistive barrier did not have sufficient overlap per the manufacturer's instructions. We

The weather resistive barrier was incomplete, leaving a portion of the wall structure exposed to the elements. We recommend repair per manufacturer's instructions.

Windows do not appear to be tape flashed appropriately. See diagram from manufacturer.

Weather barrier is compromised on south side due to plumbing install. Recommend review with manufacturers rep and/or reinstall of barrier without tears/holes, etc. to prevent water damage.

recommend repair.

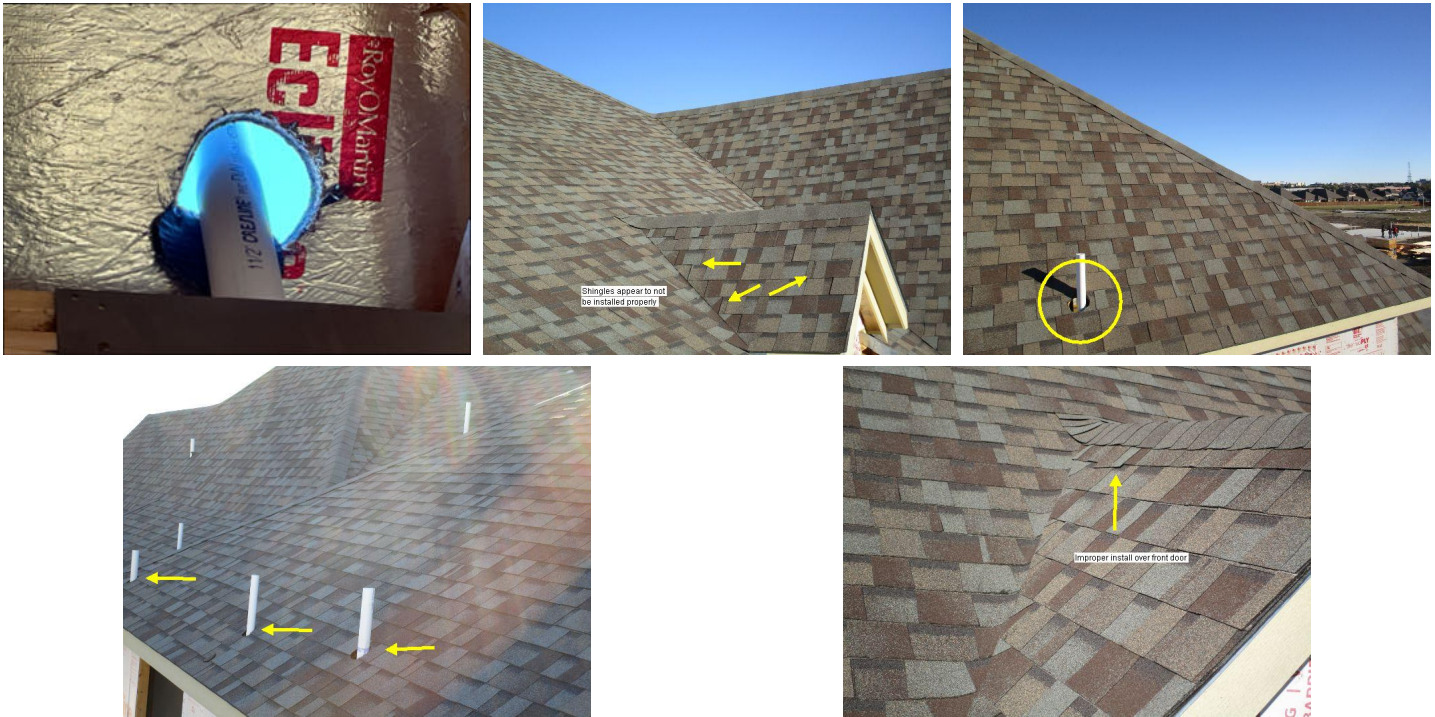
PVAC plumbing vents protruding from the roof and flashings were exposed. We recommend having these painted to protect them from the elements such as UV rays.

Damaged/torn shingles were observed on the roof. We recommend having all damaged shingles replaced to prevent further damage and water intrusion.

Apparent improper install of shingles on roof over front door at ridge and facing south.

Recommend review of roof by qualified third party roofer.

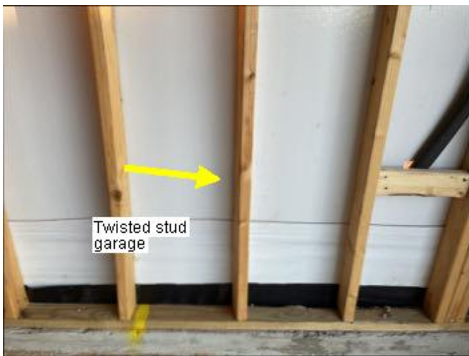
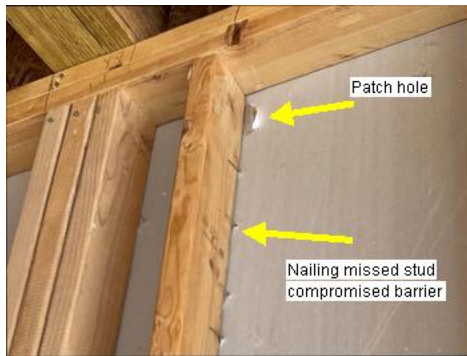
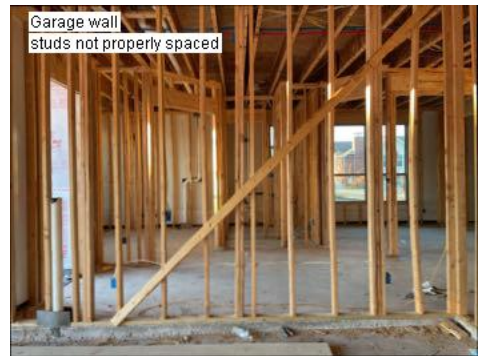
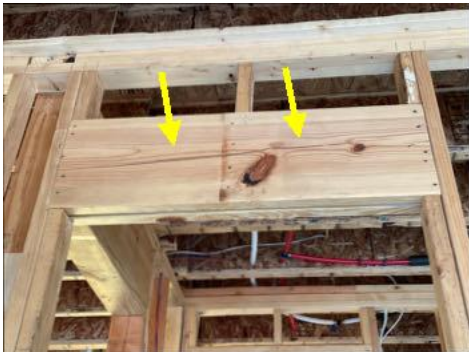
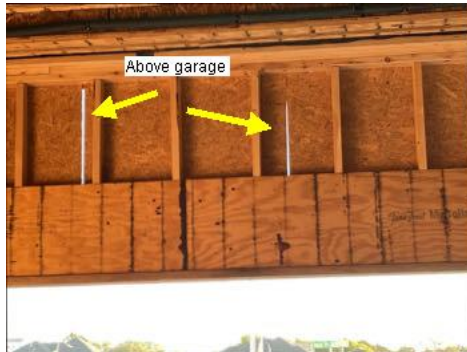
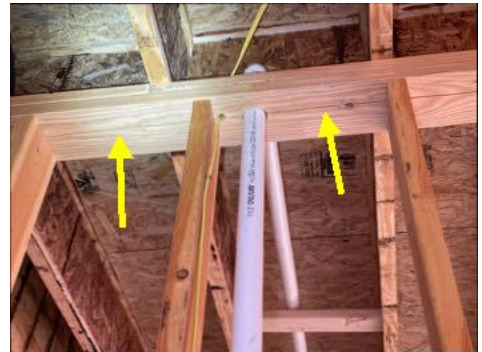
Studs were found to be out of plumb. We recommend having this adjusted to allow proper weight transfer.

Studs were found to be compromised from plumbing install and should be replaced or evaluated by a structural engineer.

Studs were found to be bent/improperly spaced

Cracked and over nailed framing noted.

Joist hangers missing/ installed upside down or with missing fasteners which compromises the hangers functionality.

Apparent mold noted on several pieces of timber. Recommend treatment before Sheetrock install.

Recommend review by structural engineer.

Recommend review prior to close.

Recommend review by structural engineer and/or qualified framer.

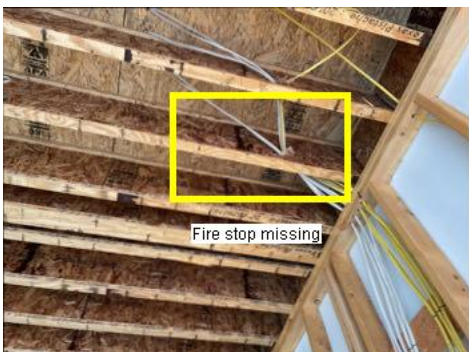
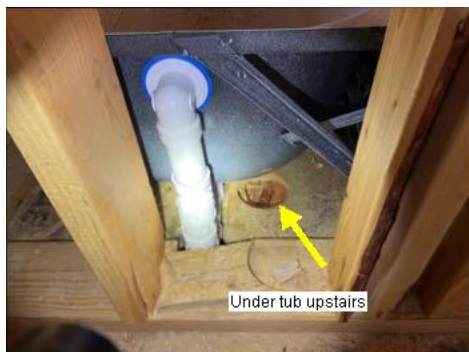
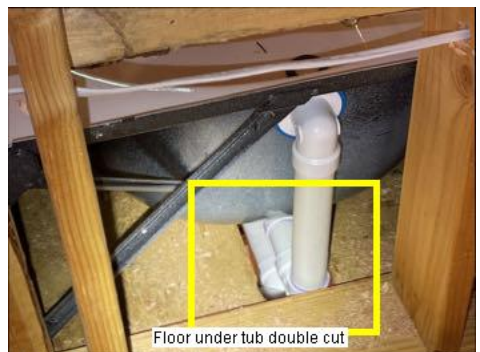
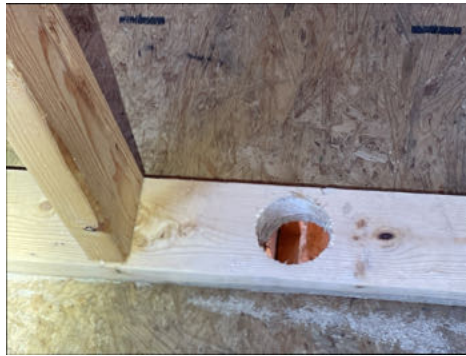
Joist hangers were lacking fasteners (nails). Each hole in the hanger should have a fastener per manufacturer's instruction. We recommend repair.

Joists were found to be missing hangers to properly secure them to the wall frame or beam. We recommend having joists hangers added per engineer's instructions. See section R802.9. This was observed in the

Holes in flooring under tubs. Recommend replacing to ensure floor can hold weight of tub.

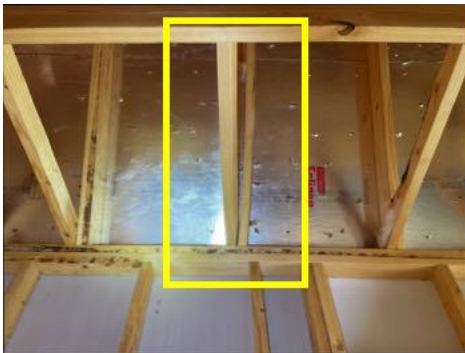
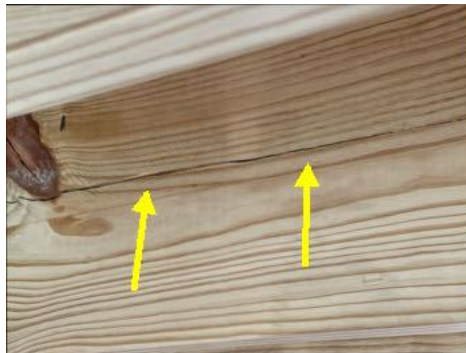
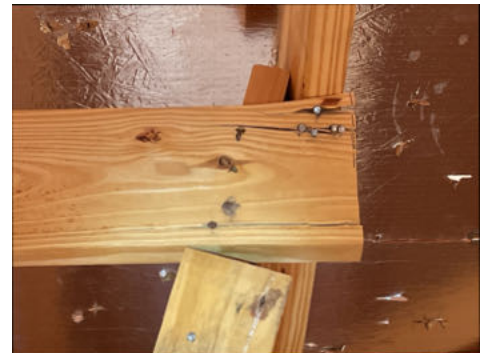
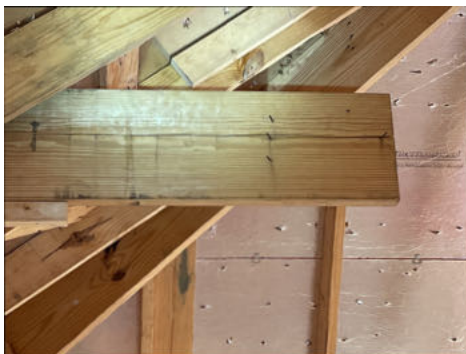
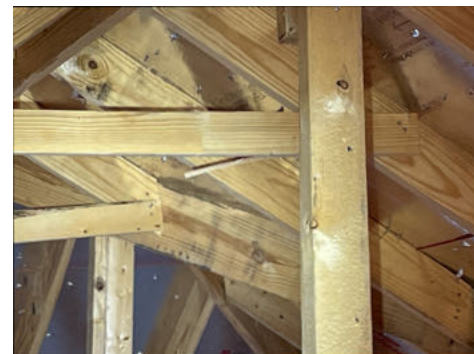
A gap between the rafters and the ridge board was observed. This will prevent a proper load transfer between the different structural elements. We recommend repair.

Cracked rafters were observed in the attic. We recommend having this repaired.

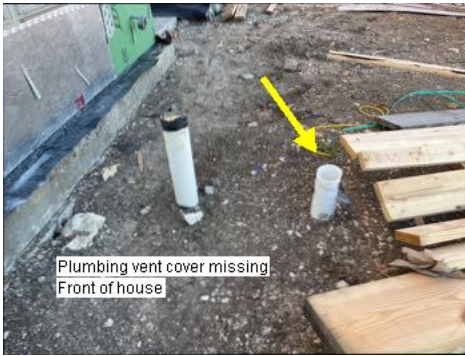
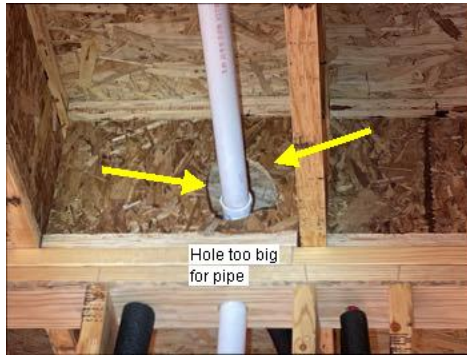
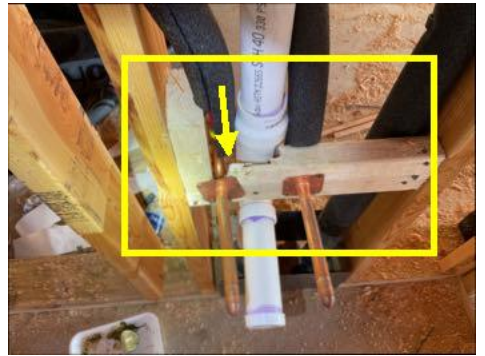
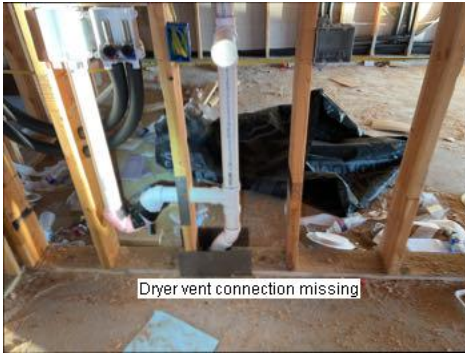
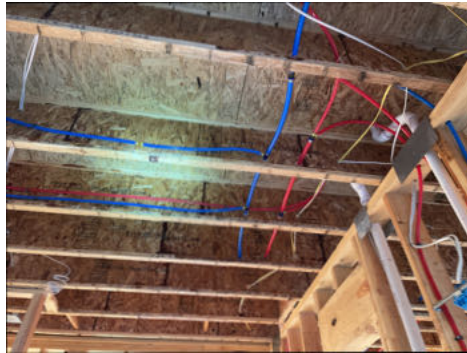
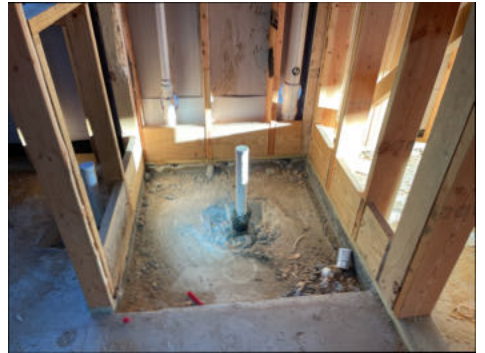
Covers missing for cleanouts. Recommend sewer scope prior to closing. Call 214-222-9208 to schedule.

Plumbing added in several places after framing and this appears to have compromised the framing members. Recommend review by structural engineer.

Chimney exhaust added by cutting wall stud. Recommend review by structural engineer.

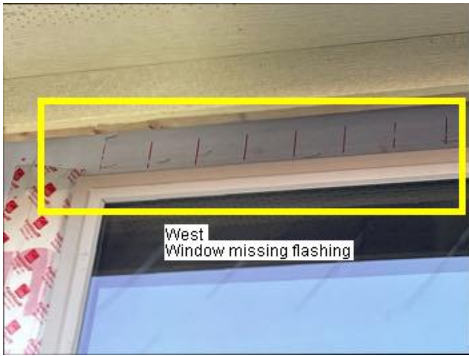
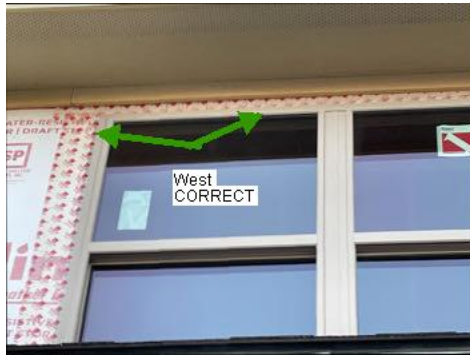
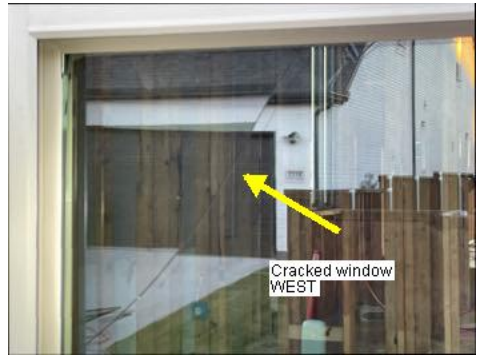
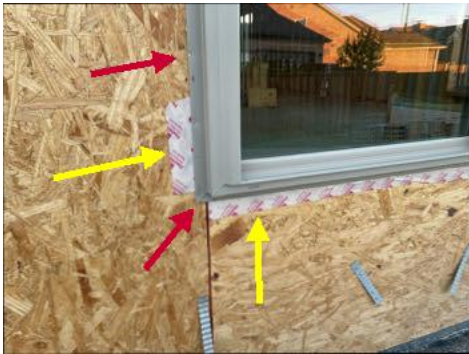
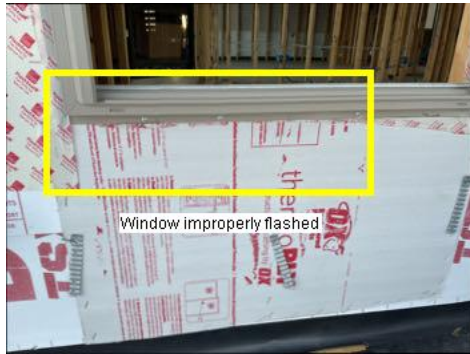
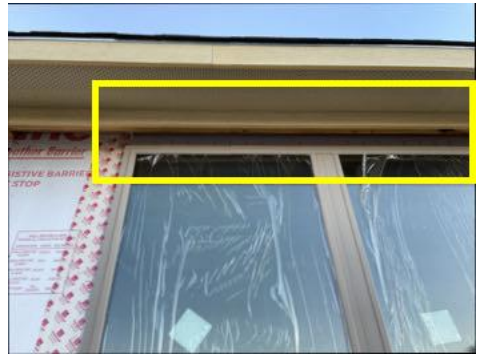
A cracked window was observed. We recommend having this replaced. This was noted in the Window missing upstairs.

Windows on exterior do not appear to tape flashed appropriately. See diagram.

Tape should be smooth throughout, extend beyond the frame and overlap so that water runs over it and out the weep holes.
