# PROPERTY INSPECTION REPORT

**12/11/2023**

**Dallas, TX  
75244**

**Inspector: Brian Wharton**

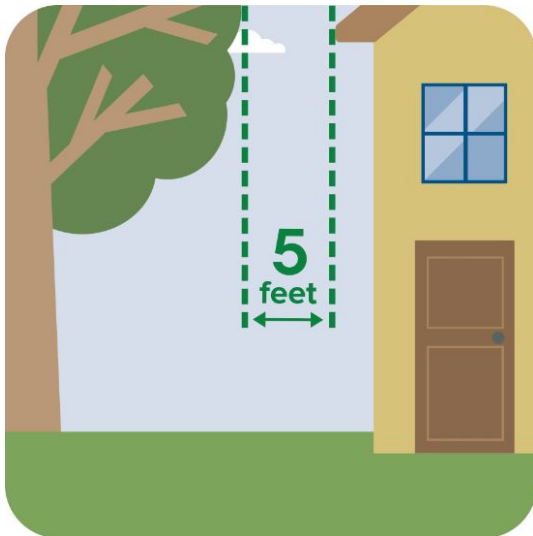
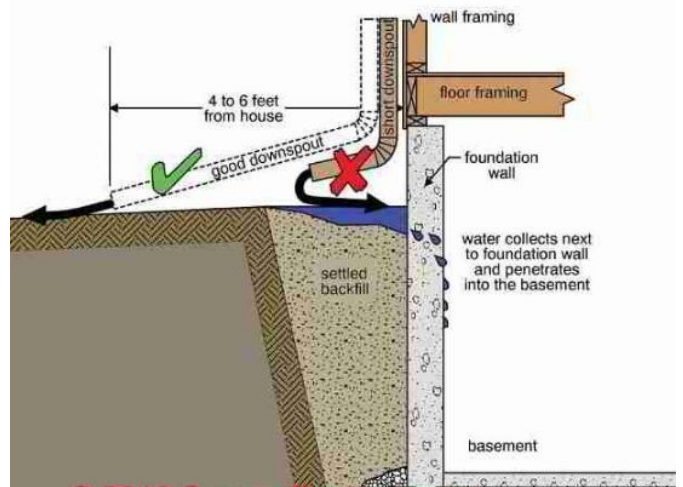
Downspout extension too short

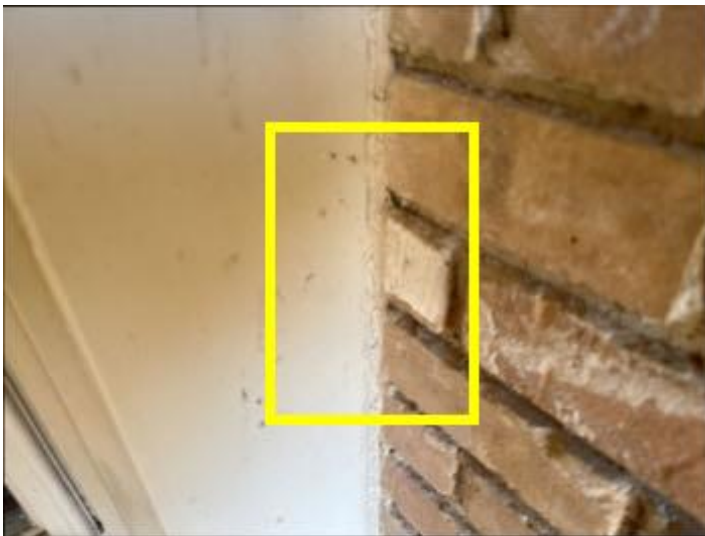
Possible water damage to wall in formal sitting area at front of house under water stain in ceiling.

Cracks in walls around door frames and windows and room transitions.

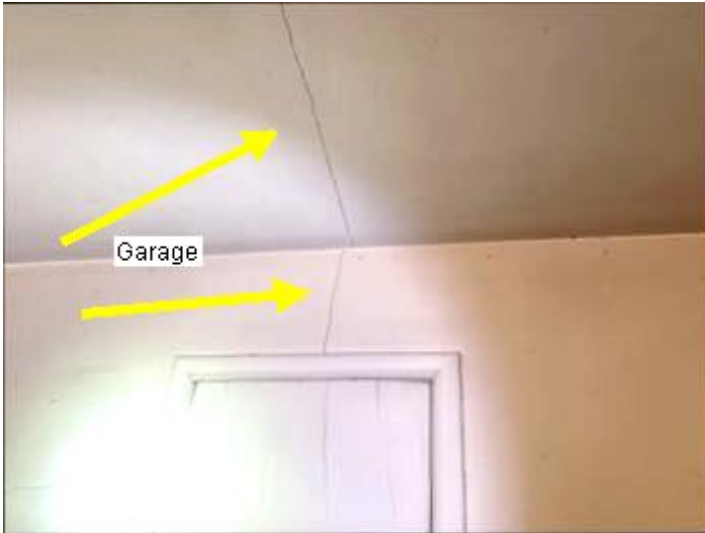
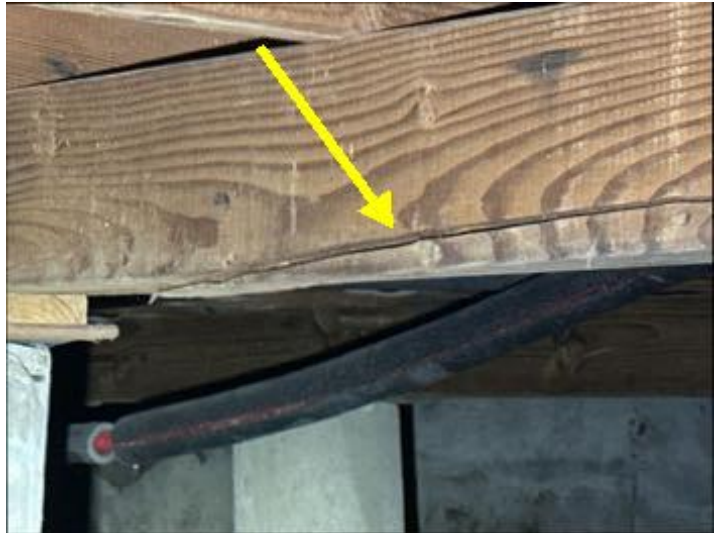
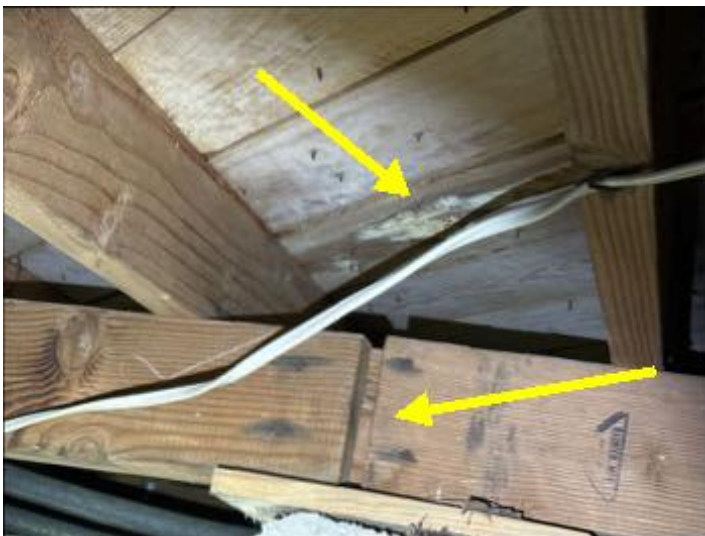
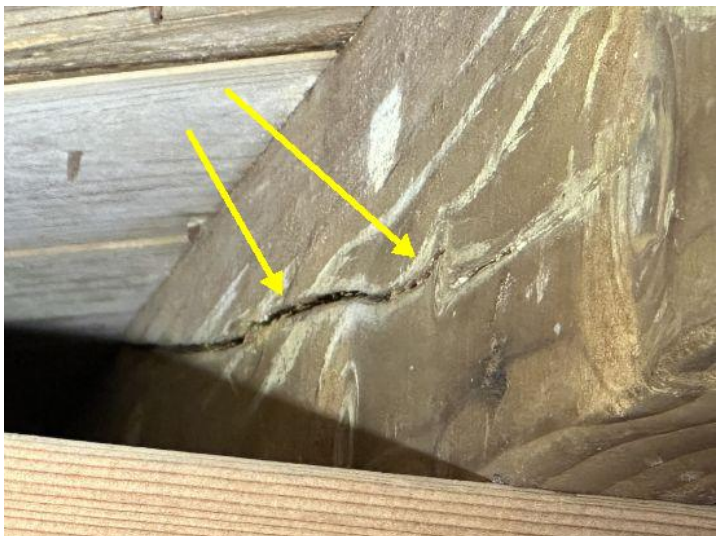
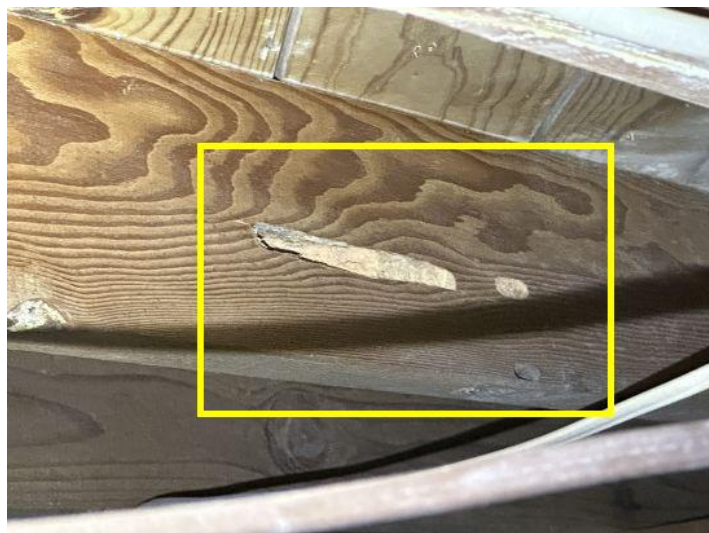
- Cracked tiles noted in kitchen and laundry room

Water stain on ceiling in front family room.

Cracks in walls and ceilings in garage.

Cracked and separating floor joists noted in crawlspace.

Possible WDI damaged floor joists noted in crawlspace.

Cracks in ceiling in sitting area by fireplace and in south bedroom ceiling.

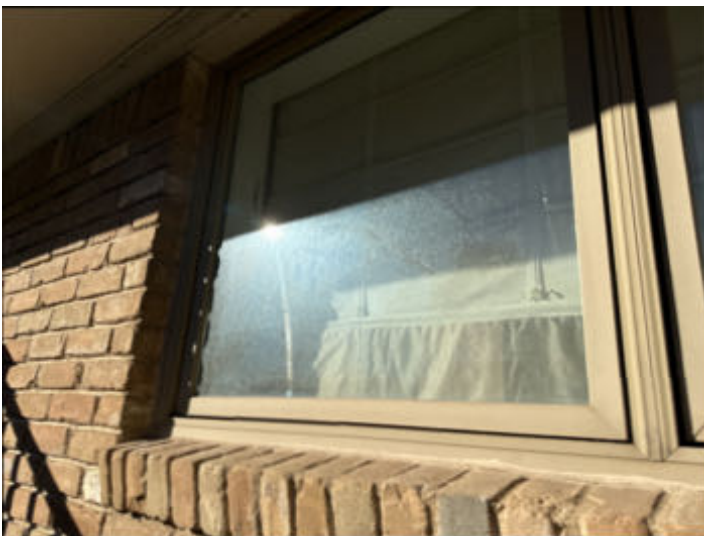
- One or more of the thermal pane windows were observed to have lost their seals. This has resulted in condensation or a fog like film to develop between the panes of glass. The thermal pane windows are no longer functional as designed when the seal is lost and replacement may be necessary

- Weather stripping and/or glazing was either damaged and/or missing at one or more windows

NOTED: inside and outside of house.

- Some of the windows were difficult to get opened, closed and/or locked. Lubrication, exercise and adjustment is recommended. Noted throughout.

Apparent frame damage noted on windows off of dining room

NOTE: had to exit house and manually close window from outside due to improper ability for casement window to "catch" window and close it to be locked.

- Caulking (sealant) maintenance is recommended around windows to prevent water infiltration and subsequent damage to the surrounding or underlying areas or adjoining materials.

Recommend review of all windows by qualified specialist.

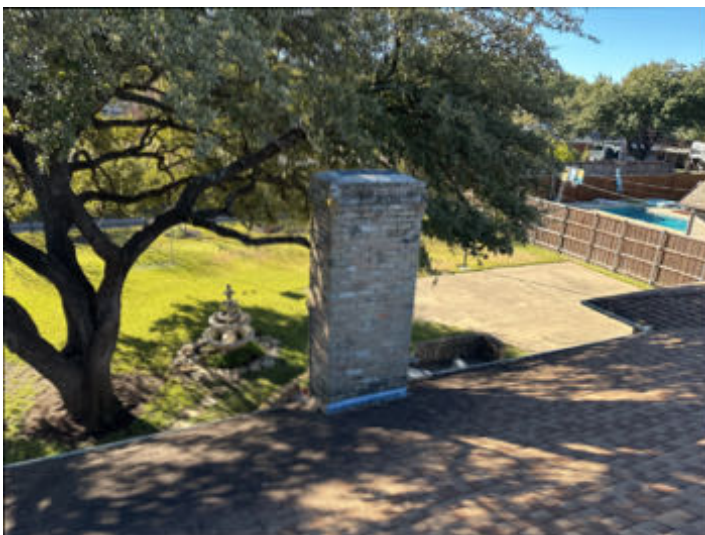
- Spalling brick was observed on the chimney(s). This is often caused by moisture getting behind the surface of the brick. While usually cosmetic, any areas of deteriorated mortar or caulking should be properly repaired before any bricks are replaced.

- It was observed that masonry cracks were present within the firebox and is in need of corrective action

Gas line into firebox appeared to be broken and end of life.  
NOT tested by inspector.

- Excessive build-up of soot or creosote was observed in the flue(s) and/or fireplace(s). Creosote is a fire hazard. Cleaning and inspection by a qualified chimney sweep is recommended. Flue or firebox defects may be hidden by soot and creosote.

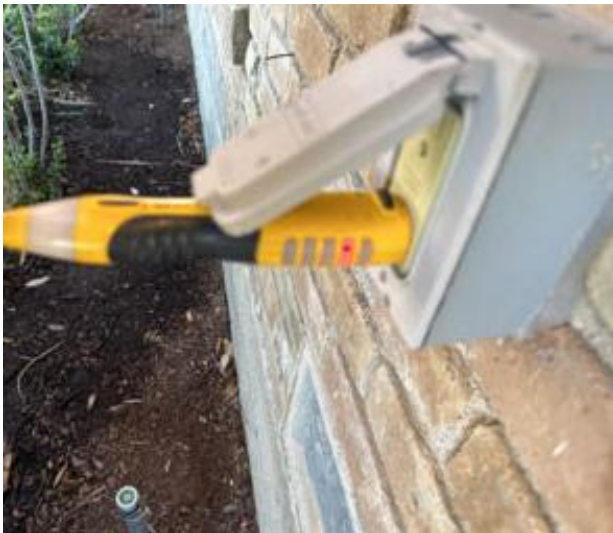
- Open wire splices were observed. This is hazardous because the metal conductors can be exposed or may be pulled apart. Recommend further review and correction of all open splices (into proper junction boxes) by a qualified electrician. >Open Splice Location(s) NOTED in attic and in crawlspace

THIS IS A SAFETY HAZARD

- One or more electrical outlets did not appear to be "grounded" when tested. Grounding provides an emergency path for electricity and helps to prevent electrical shock. Recommend further review by a qualified electrician to determine cause and options for correction of the open ground conditions  
NOTED outside and in bathrooms with GFCI's  
NOTE: RENDERS GFCI OUTLET SAFETY FEATURES USELESS.

NOTE overheated outlet noted in laundry room closet.

- Open junction boxes were observed. Recommend all junction boxes have proper covers installed for personal safety. Open Junction Box Location(s): NOTED in attic and crawlspace. THIS IS A SAFETY CONCERN.

Loose outlet cover for furnace on off switch in hall closet.

- Inadequate smoke alarm coverage was observed and it is recommended that additional smoke detectors and CO2 detectors be installed in accordance with current building standards. The NFPA {National Fire and Protection Agency} recommends one smoke alarm on each level, every bedroom and adjoining hallway, above stairwells and a CO2 detector in the garage and outside each bedroom with fuel fired appliances. A primary fire extinguisher is recommended on each level with a UL rating of 2-B:C.

**RECOMMEND REVIEW OF ELECTRIC SYSTEM BY LICENSED ELECTRICIAN.**

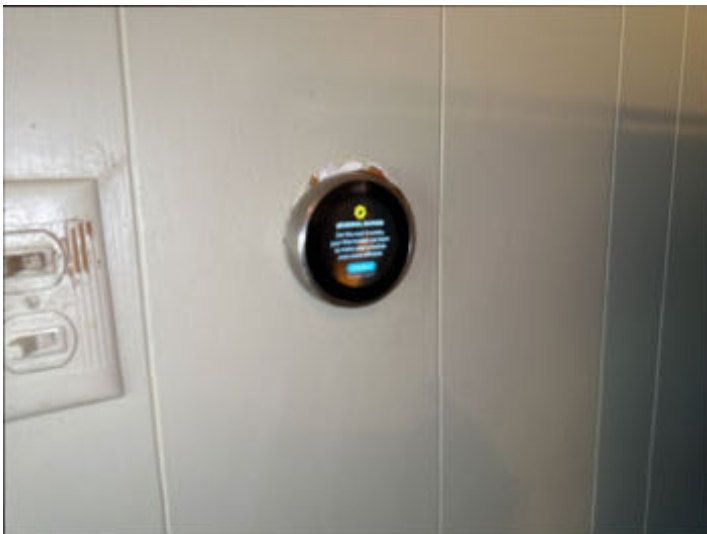
- The unit appeared to be functioning as intended at the time of the inspection
- The thermostat was found be operational under normal controls, however, enhanced features and settings were not tested as apart of this inspection. Any deviation from basic normal controls would listed in this section below.
- The HVAC system should be further evaluated by a Qualified Licensed HVAC contractor prior to the expiration of a warranty and/or option period
- The gas supply line was not equipped with a required drip leg trap just before the appliance connector. This condition does not meet current mechanical standards and should be corrected

Electric wiring entering cavity is not protected with conduit and does not have proper gasket at entrance to unit. Over time this wires protective sheathing can be worn away and energize the furnace cavity creating a safety concern.

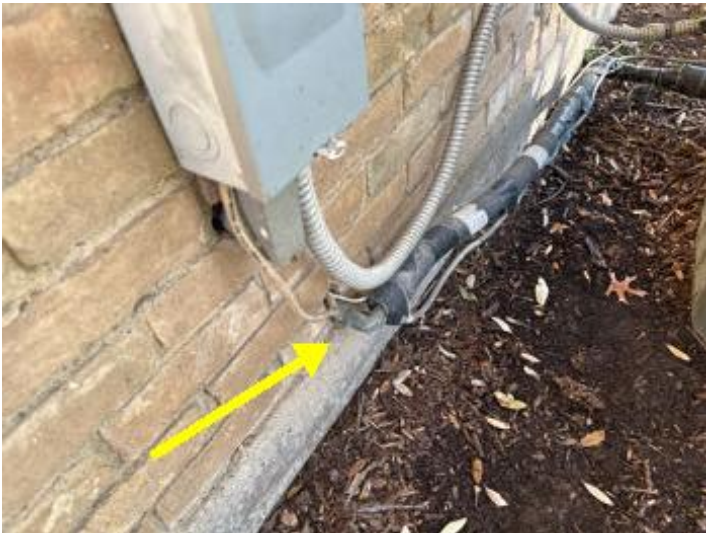
- The unit appeared to be cooling inadequately when the temperature drop was measured across the system. Poor cooling can be caused by several possible deficiencies and further review and correction by a qualified heating contractor is recommended. The normal operating range tested is between 15 and 22 degrees. This unit achieved 11 degrees differential.

- The breaker providing protection and electric service to the air conditioning unit at the contractor cut off by the unit appears to be too large. The system appears to call for a max breaker size of 45amps but the cut off is rated for 60 amps.

Recommend service and review of system by licensed HVAC professional.

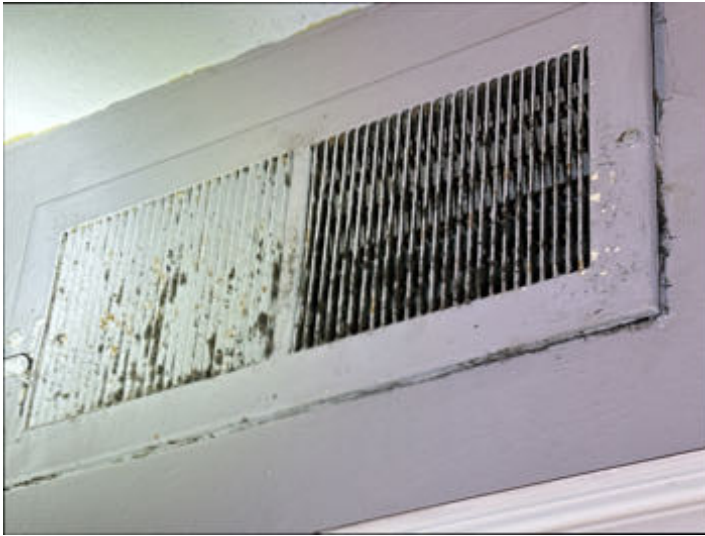
- Duct work should be suspended and not take hard turns to avoid crimping
- The air filter(s) was dirty at the time of the inspection. Dirty filters restrict air flow which may cause short cycling and can shorten the life of the heating equipment. Recommend changing (or cleaning, if a reusable type) the filter in accordance with the filter manufacturer's and the heating equipment manufacturer's directions.
- Registers are dirty

Sampling of substance on registers taken and will be included in mold report  
Inspector holds Texas Mold License TDLR MAT1313.

Recommend review of by licensed HVAC professional.

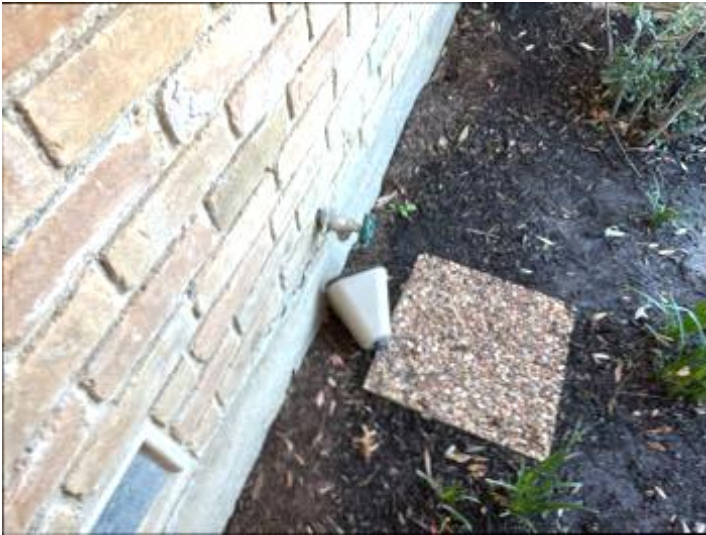
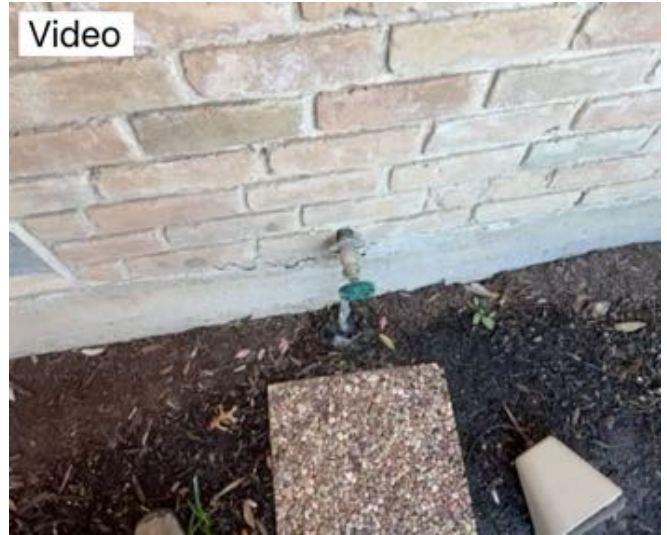
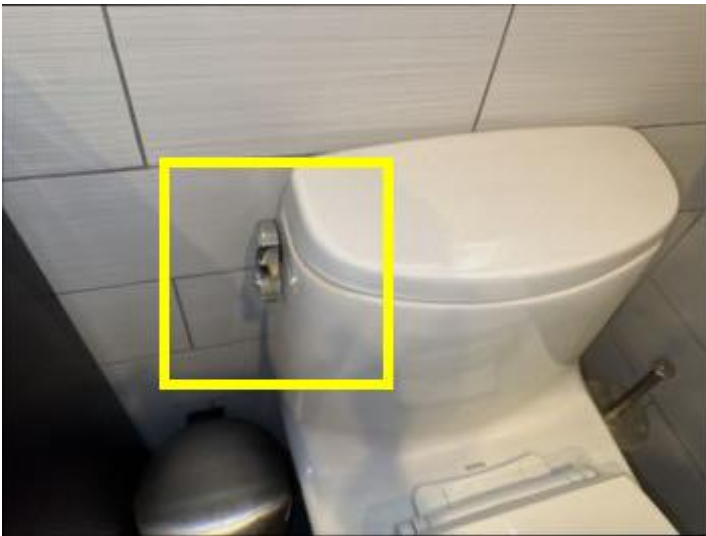
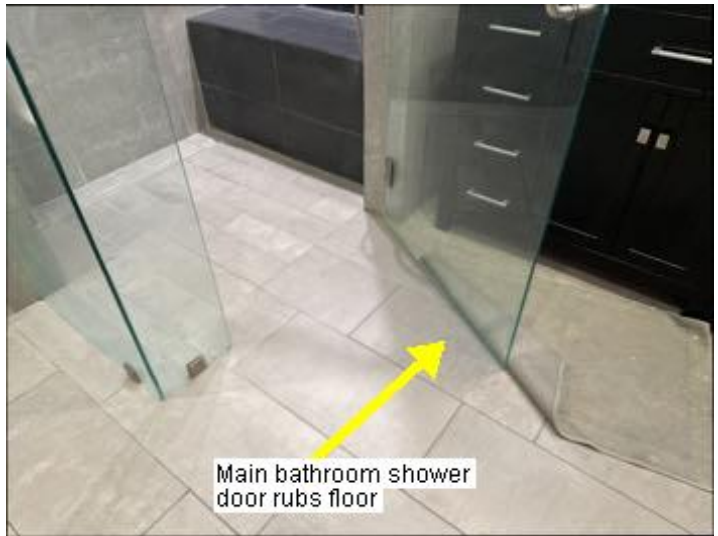
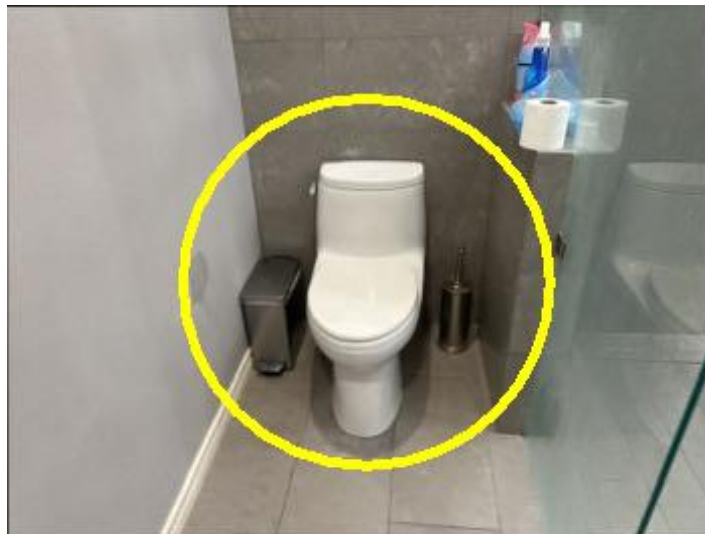
- The exterior garden hose faucets (hose bibbs) was not a frost-proof type. Damage may occur in colder weather if the water in the garden hose faucet(s) freezes. Recommend checking with the current owner as to the location of an interior valve so the garden hose faucet(s) may be shut off and drained. Installation of frost-proof garden hose faucets by a licensed plumber may also be considered.

- The hose bibb was found to be loose. Tightening is recommended.
- The toilet fixture appeared to be loose at the floor. This condition can cause the toilet to leak at the base, potentially causing damaged and/or rotted flooring. Proper correction by a qualified contractor is recommended.

NOTED in main bathroom

Toilet handles deficient at all toilets in home.

Recommend review of all concerns by licensed plumber.

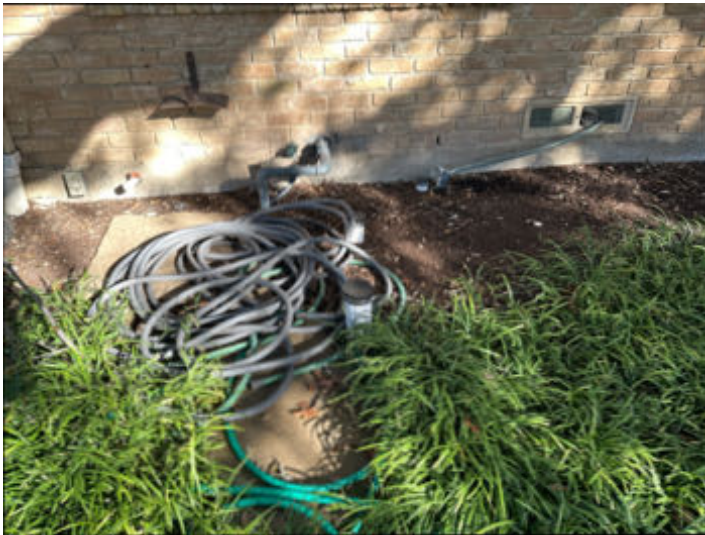
- The exterior main cleanout was located at the rear of the structure
- Vent pipes are noted as PVC and Galvanized Steel
- Rubber seal at sewer line away from house appears to be installed improperly and may eventually fail.

Rubber plumbing stack boot jacks are depressed and will eventually fail and cause water leaks,.

Recommend review of all concerns by licensed plumber.

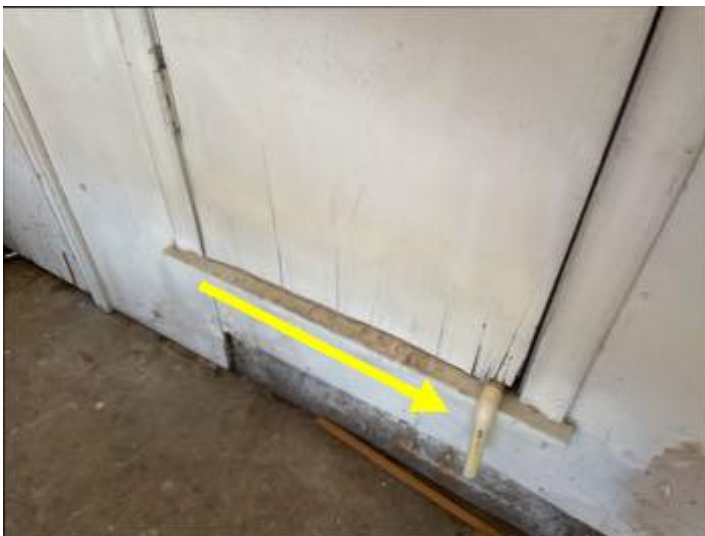
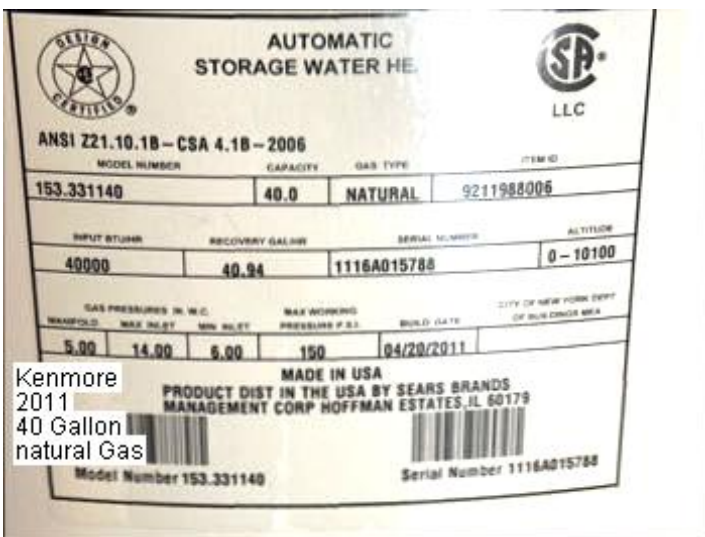
- The TPR valve drain pipe was not terminated on the exterior and is a Safety Hazard
- It was noted that the water heater was not equipped with a corrosion resistant drain pan to discharge on the exterior
- Sediment trap missing from water heater
- The water temperature at the faucet locations was noted to exceed the {120 degree} scald limit and adjustments on the temperature control are recommended

Recommend review of all concerns by licensed plumber.

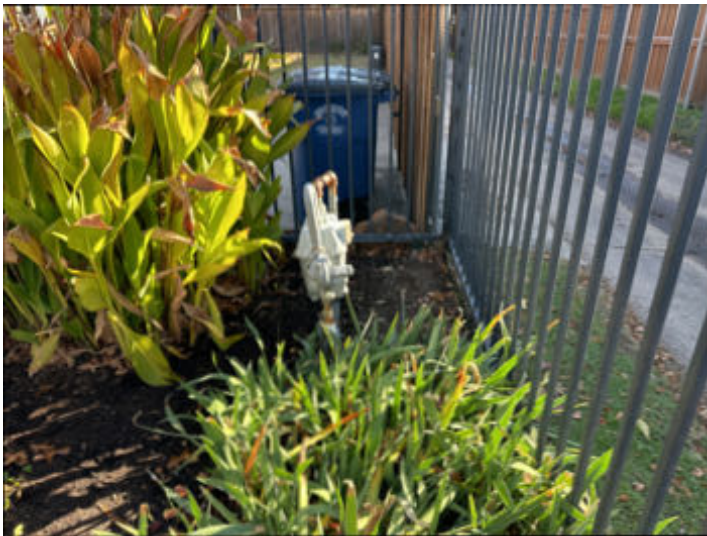
- Gas meter supply line missing electric bond

Water heater gas line missing sediment trap

Gas furnace missing drip leg

Gas fireplace not tested as gas supply line appears to be damaged

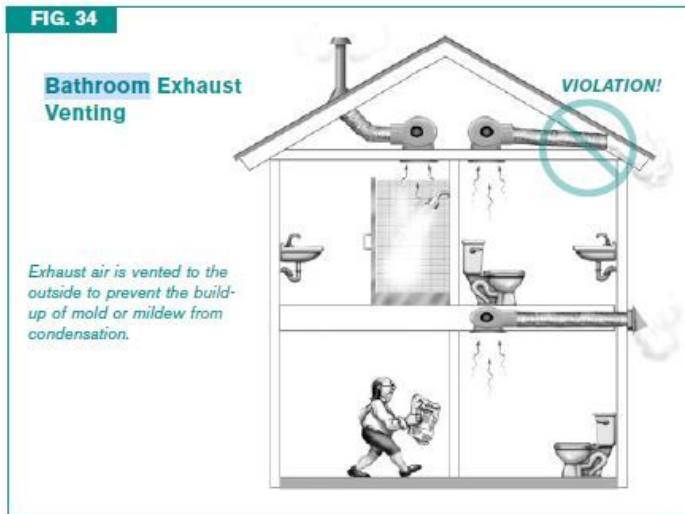
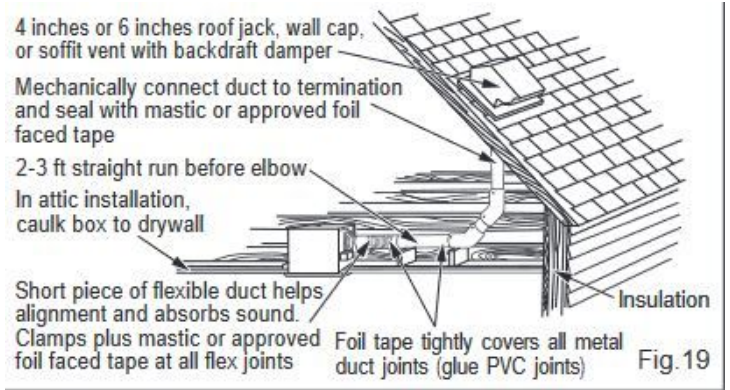
- Bathroom exhaust fans do not appear to properly vent to EXTERIOR of home. Venting to attic or inside home (including walls) does not properly remove the moisture from the home. Consult a qualified contractor for proper remedy solutions.

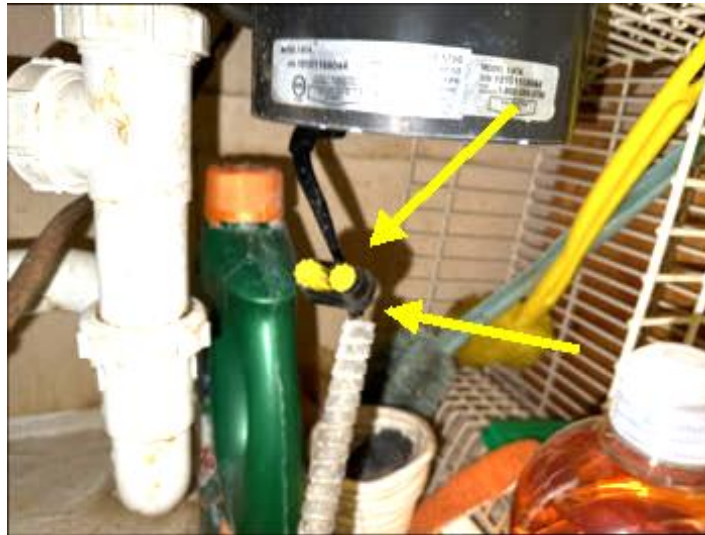
- Disposal was inoperable at time of inspection.

Not wired properly nor fully installed.

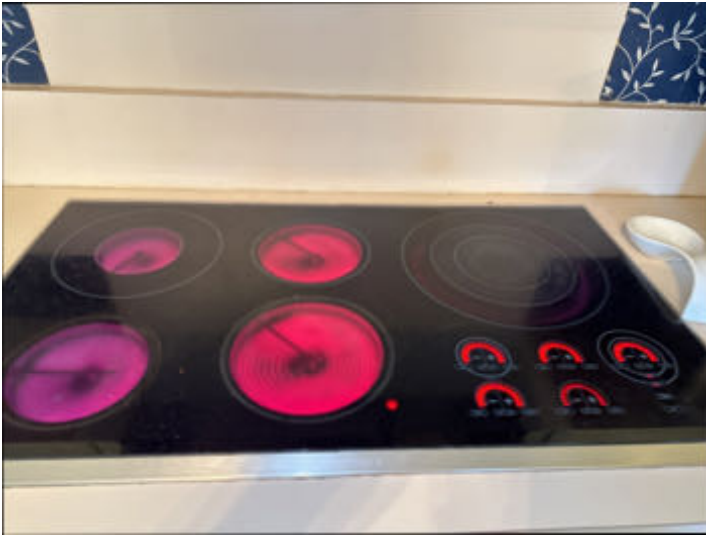
- Oven(s)/cooktop: Electric
- Cooktop appeared to work as intend.
- Bottom oven appeared to have deficient temperature setting as the oven was set at 350 degrees and reached over 500 degrees.

Recommend review by licensed appliance contractor.

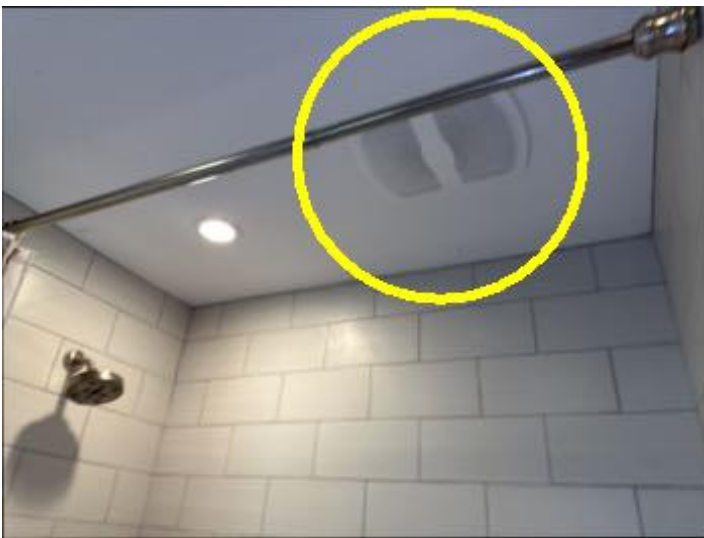
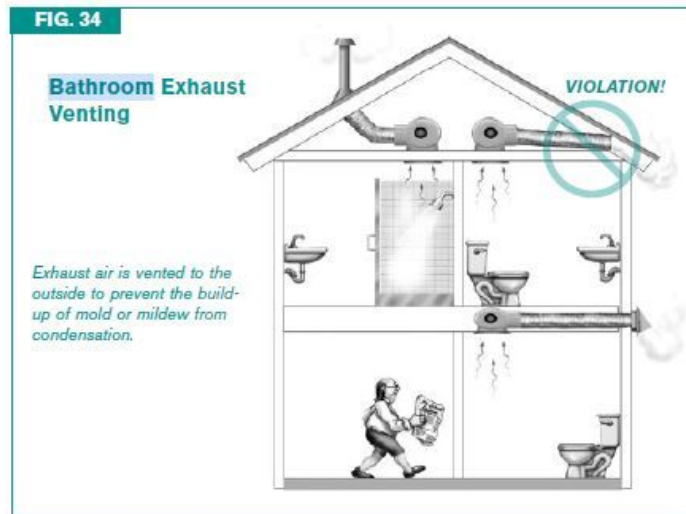
- The vent fan terminated in the attic space and should be vented to the exterior as per current building standards

Bath fan over shower enclosure in hall bath - need to review with seller to review installation manual to ensure that this unit is rated for placement over the shower and not next to it (unit must be properly moisture rated).

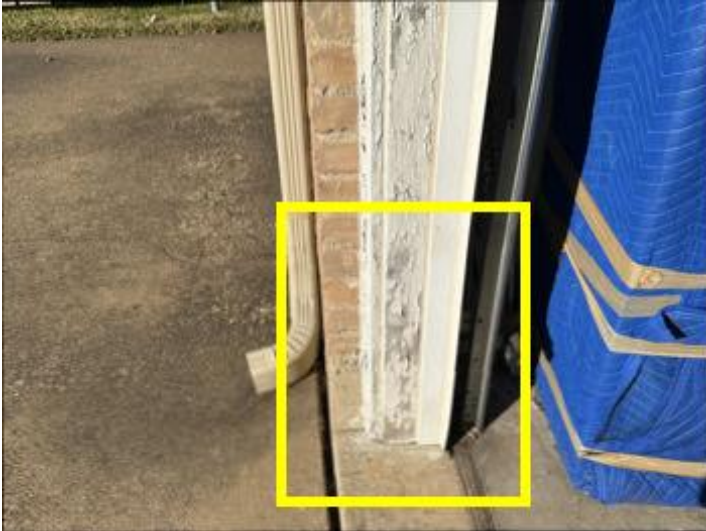
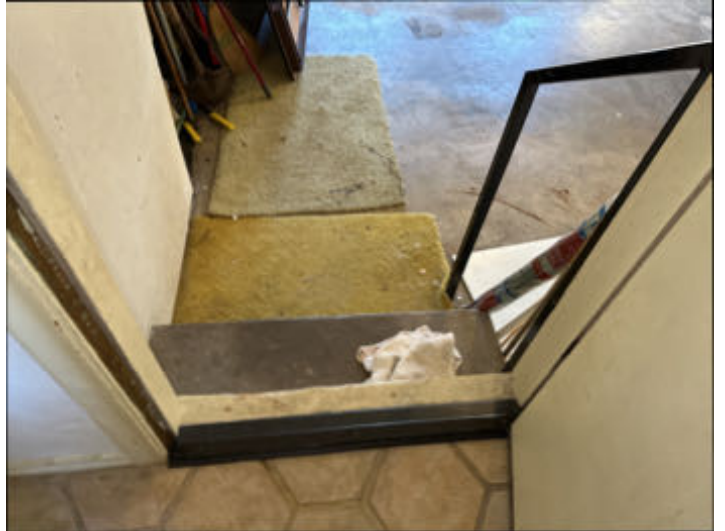
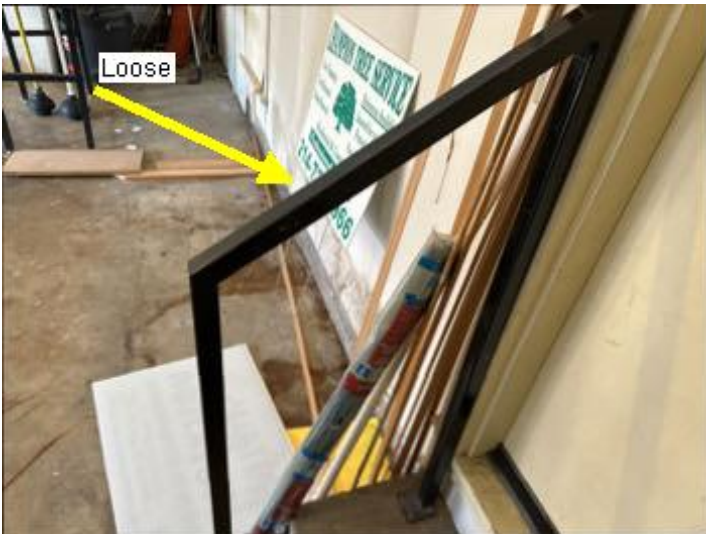
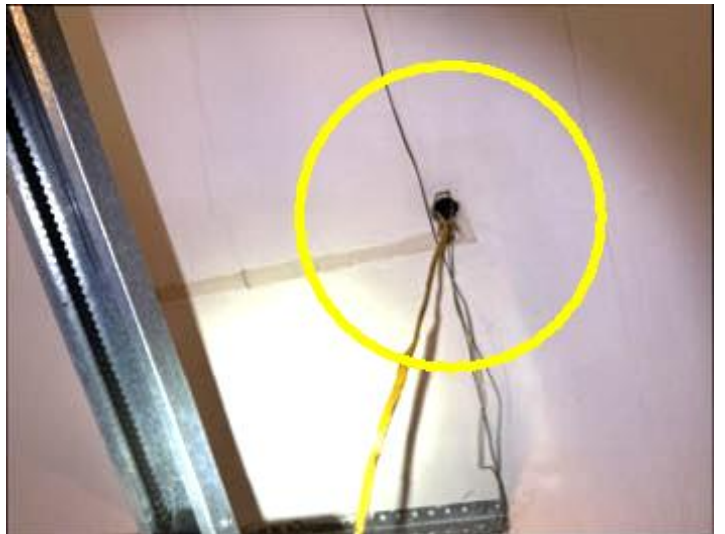
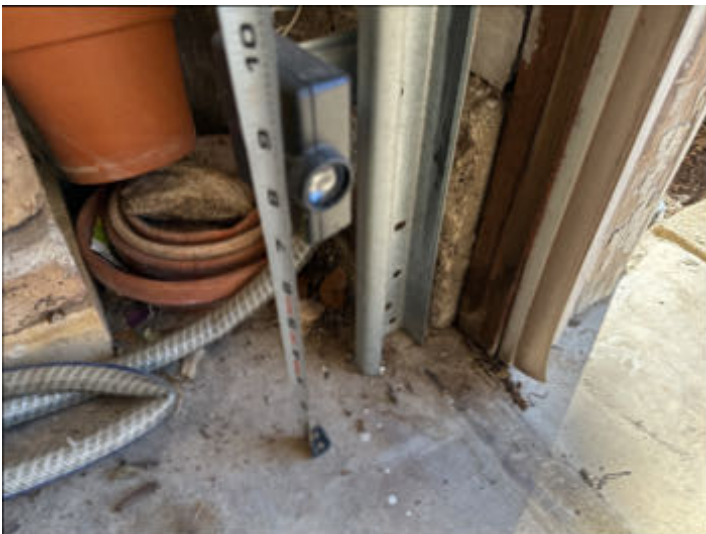
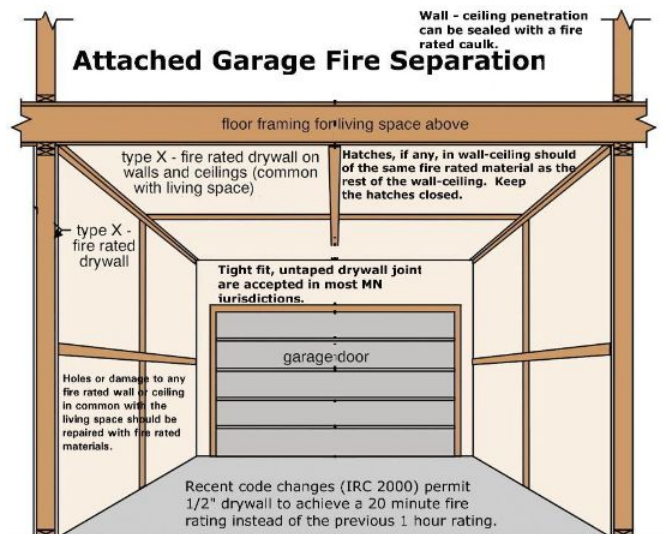
- Openings and/or non-fire rated materials on the walls and/or ceiling were noted that are a breach of the common firewall. These openings could allow a garage fire to quickly migrate into main structure. Proper correction is recommended for personal safety. The walls separating the garage from the home living space did not meet generally-accepted current safety standards firewall requirements. Firewalls are designed to resist the spread of a fire which starts in the garage for a certain length of time in order to give the home's occupants adequate time to escape. Generally-accepted current safety standards require an intact firewall be installed between the garage and living space which meets the following requirements: 1. Drywall joints must be fire-taped. 2. The firewall must be continuous between the garage and living space 3. Wall penetrations such as ducts must be made of metal. 4. A door through a firewall (fire door) may be: a. A solid core slab door with a minimum thickness of 1 3/8 inches. b. A sheet metal door. c. A 20-minute fire-rated panel door. 5. A fire door must also be self-closing, typically with a spring-type hinge. 6. Hatches providing access to attic spaces must conform to firewall requirements. The inspector assumes no responsibility for confirming drywall thickness.

- The side jamb(s) at the overhead garage door(s) were rotted. Proper repair and refinishing is recommended.

Rail at steps to house appears to be loose.

- The garage door did NOT automatically reverse under reasonable resistance and adjustments are recommended

Recommend review of garage door by certified garage door specialist.

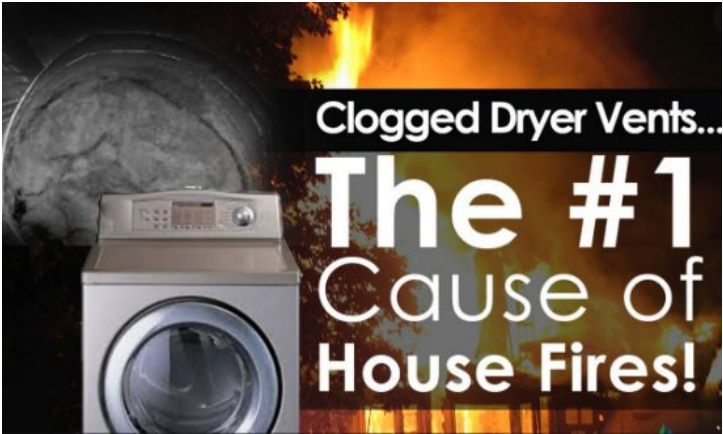
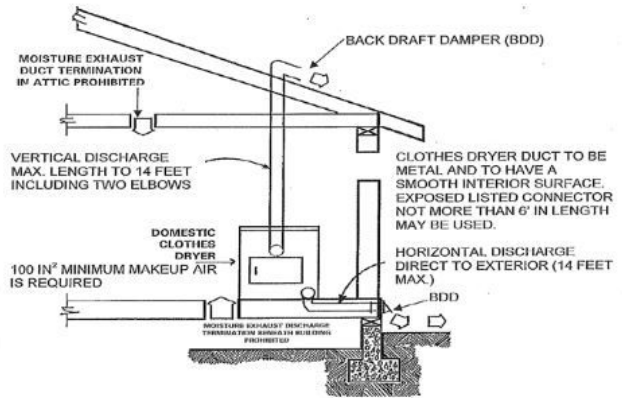
- The dryer vent pipe was found to be dirty at the time of the inspection. Dirty pipes are typically a result of accumulated lint and a potential fire hazard.

- No backdraft damper door observed on the dryer vent

- It is recommended that the dryer line/vent be cleaned at move in and a new dryer line meeting current manufacturer specs and code be installed. The leading cause of fires from clothes dryers is the failure to clean the lint and other debris that can accumulate in and around them. Inspectors can make the following recommendations to their clients:

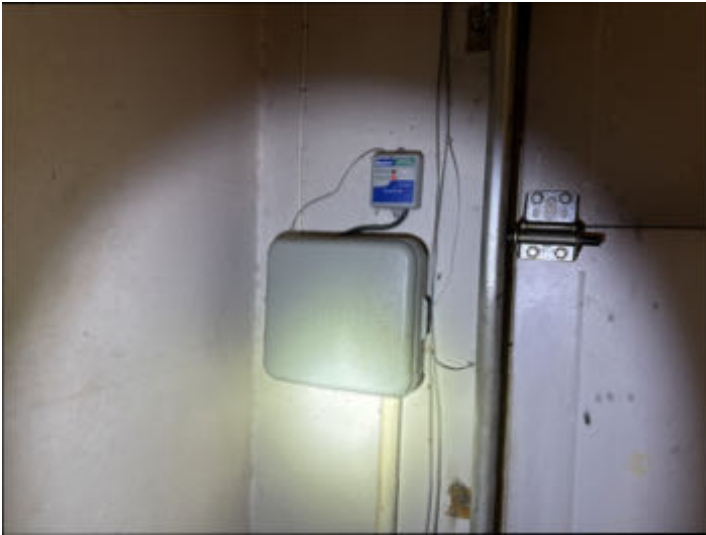
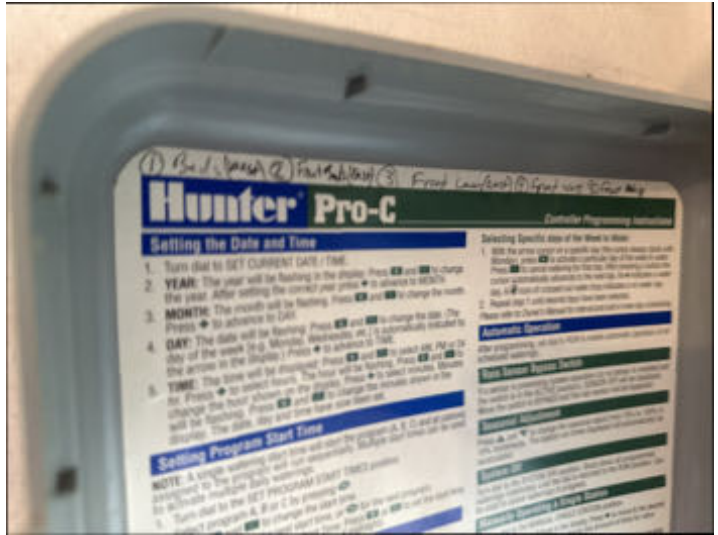
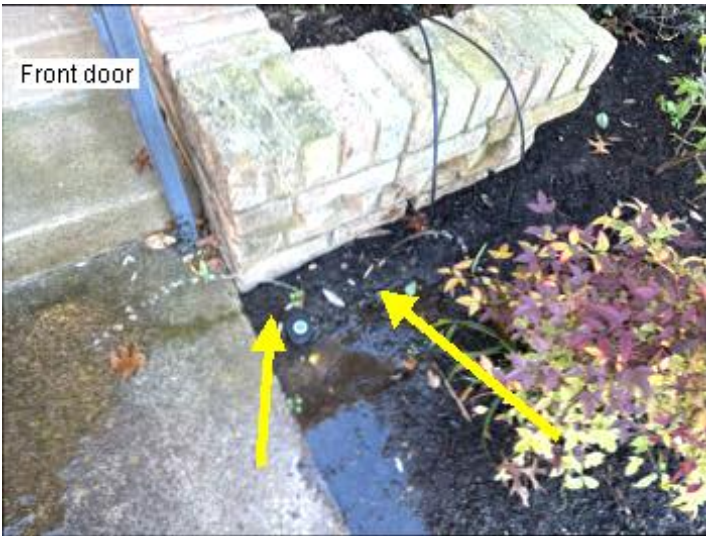
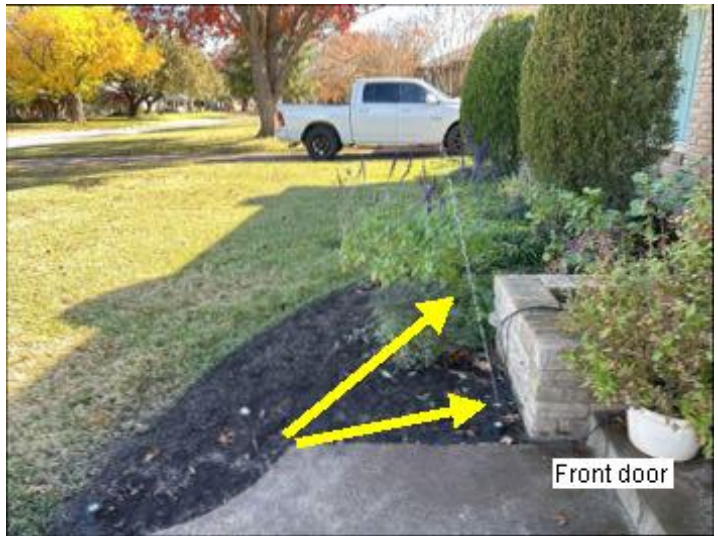
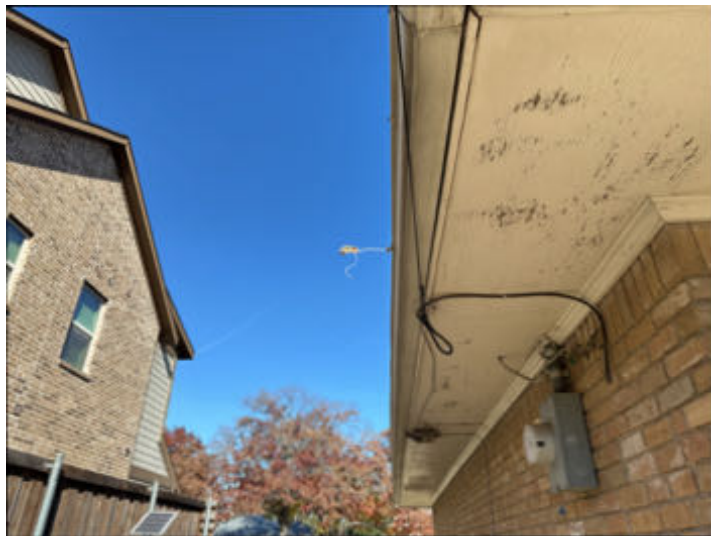
Zone 1 has leaks and does not function as intended.

Recommend review by qualified irrigation specialist.
