The BrickKicker

Phase Inspection Report

Texas Pistache Dr, Dallas, TX
Inspection prepared for:
Real Estate Agent: -

Date of Inspection: 10/30/2021 Time: 8:00 AM
Age of Home: 2021 Size: 3000
Order ID: 635

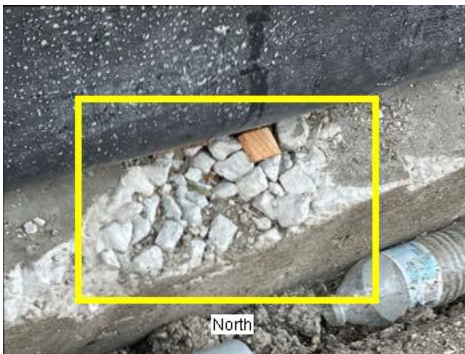
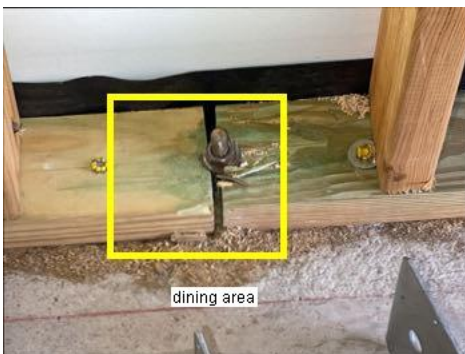
Wood form boards were left in place and were in contact with the foundation. We recommend having them removed to prevent creating conducive conditions for wood destroying insect activity.

A sill plate had been cut/was damaged. We recommend having this repaired per structural engineer's instructions.

A loose anchor bolt was observed at a sill plate. We recommend having this secured prior to hanging the sheetrock.

Anchor bolts off center and not properly fastened

Fore ant infestation

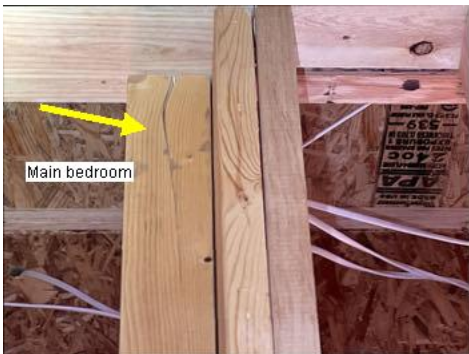
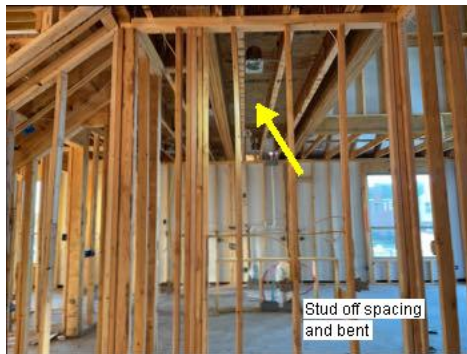
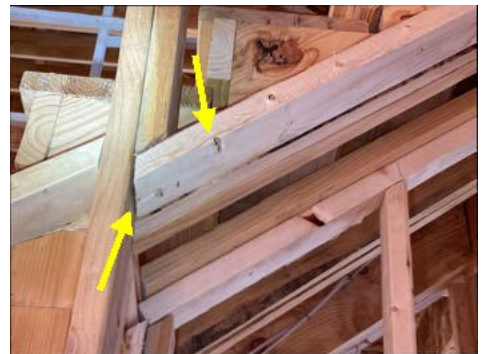
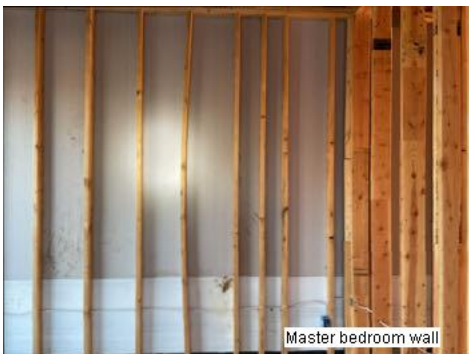
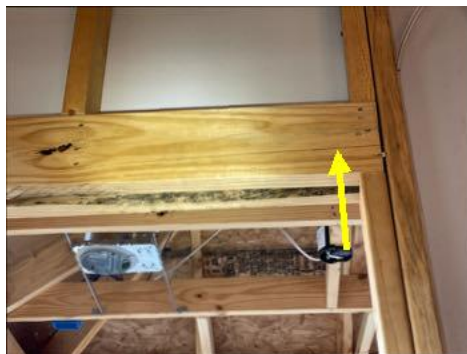
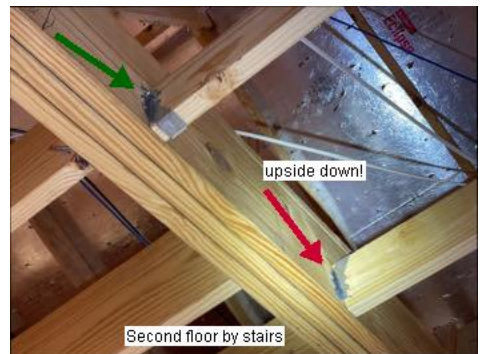
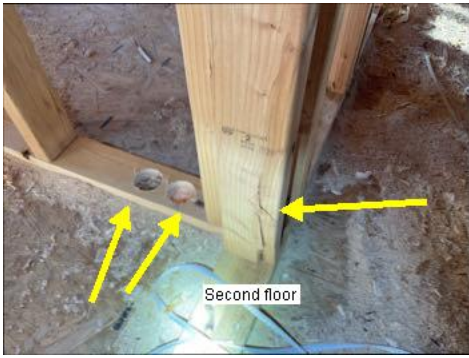
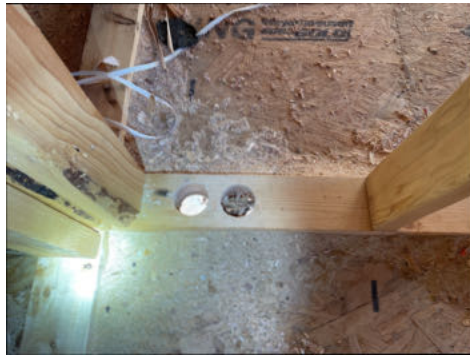
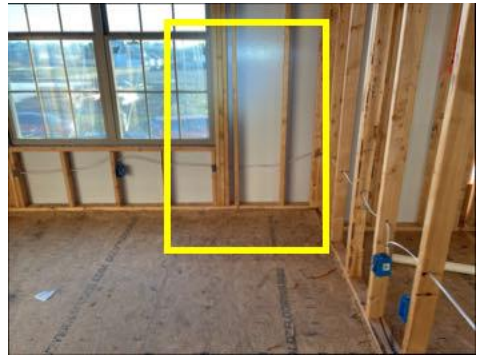
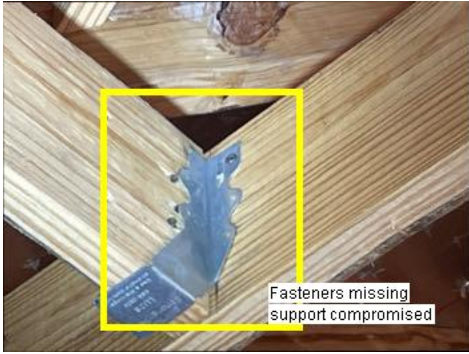
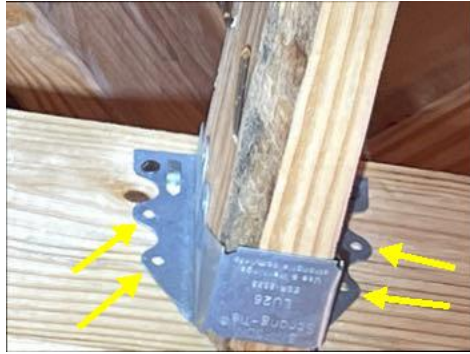
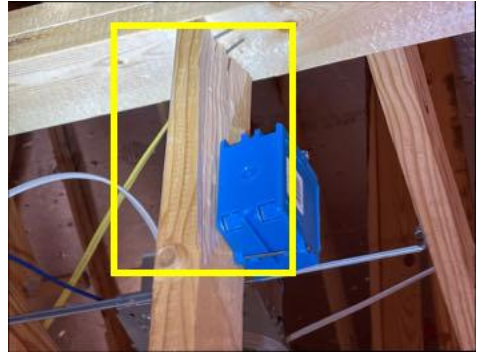
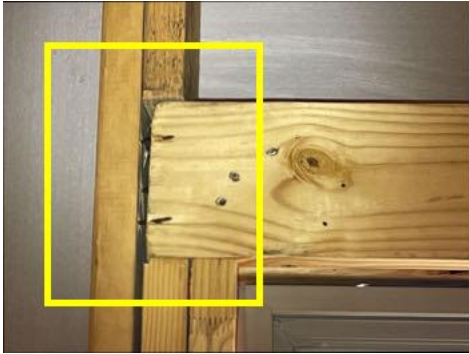
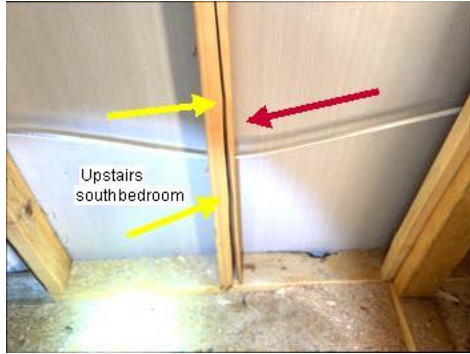
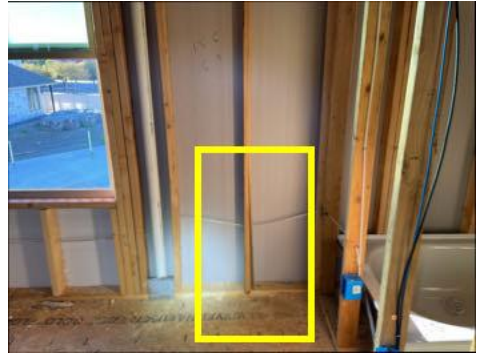
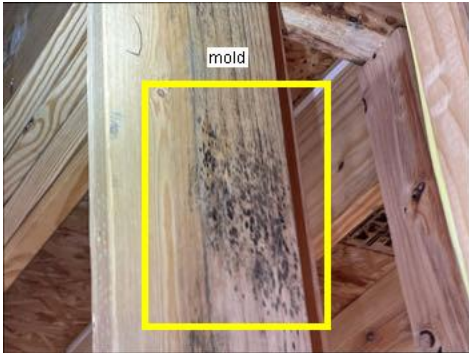
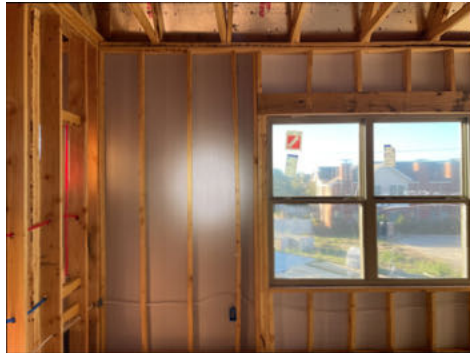
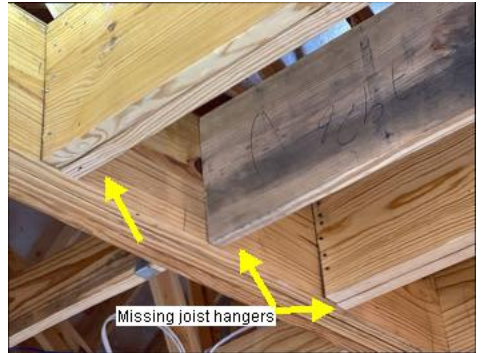
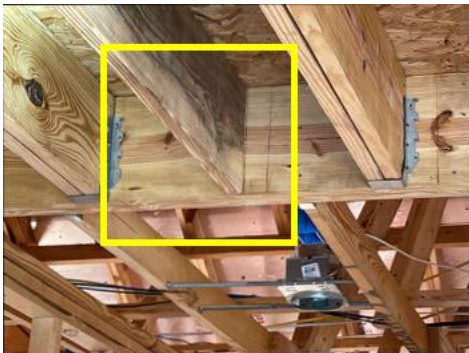
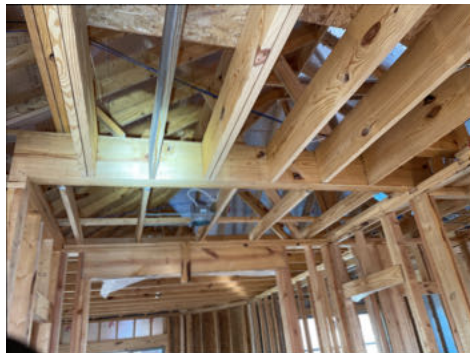
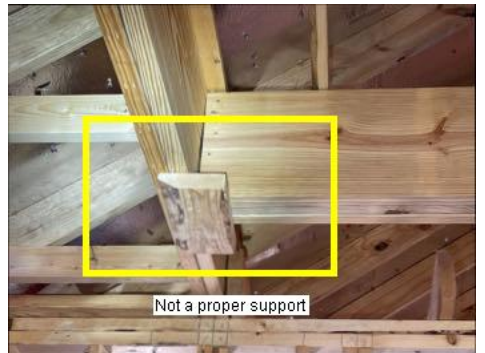
Studs were found to be out of plumb. We recommend having this adjusted to allow proper weight transfer.

Studs were found to be compromised from plumbing install and should be replaced or evaluated by a structural engineer.

Studs were found to be bent/improperly spaced

Cracked and over nailed framing noted.

Joist hangers missing/ installed upside down or with missing fasteners which compromises the hangers functionality.

Apparent mold noted on several pieces of timber. Recommend treatment before Sheetrock install.

Recommend review by structural engineer.

Recommend review prior to close.

Recommend review by structural engineer and/or qualified framer.

Recommend further testing. Call 214-222-9208 to schedule.

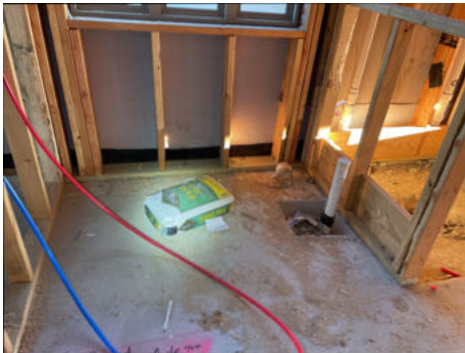
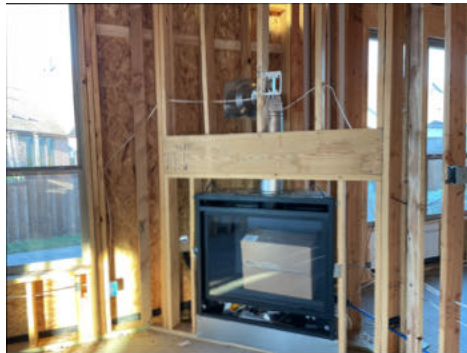
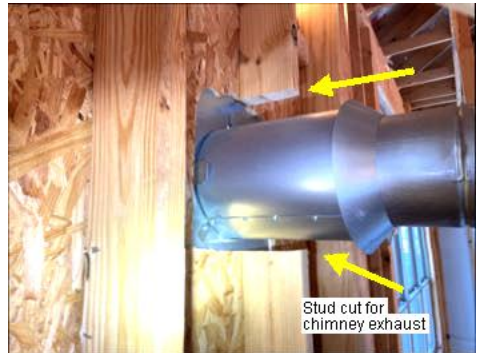
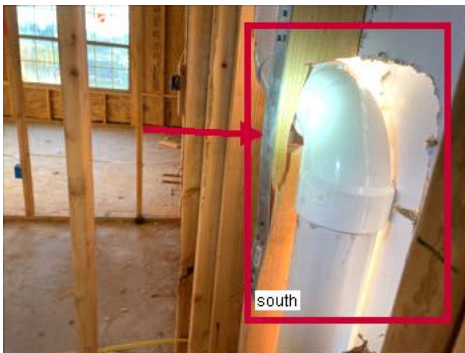
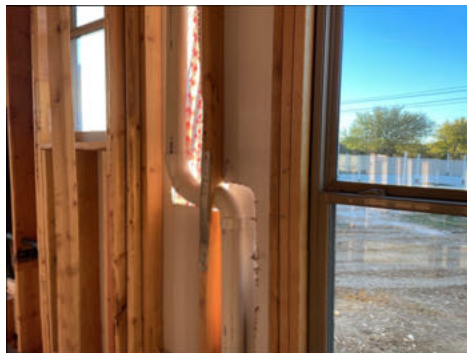
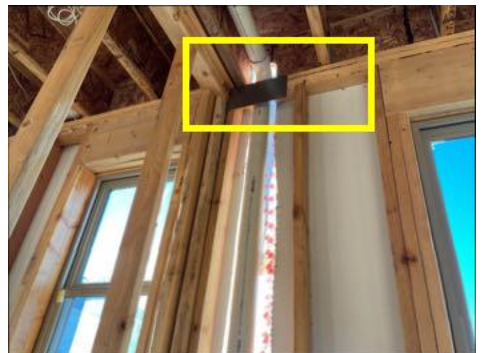
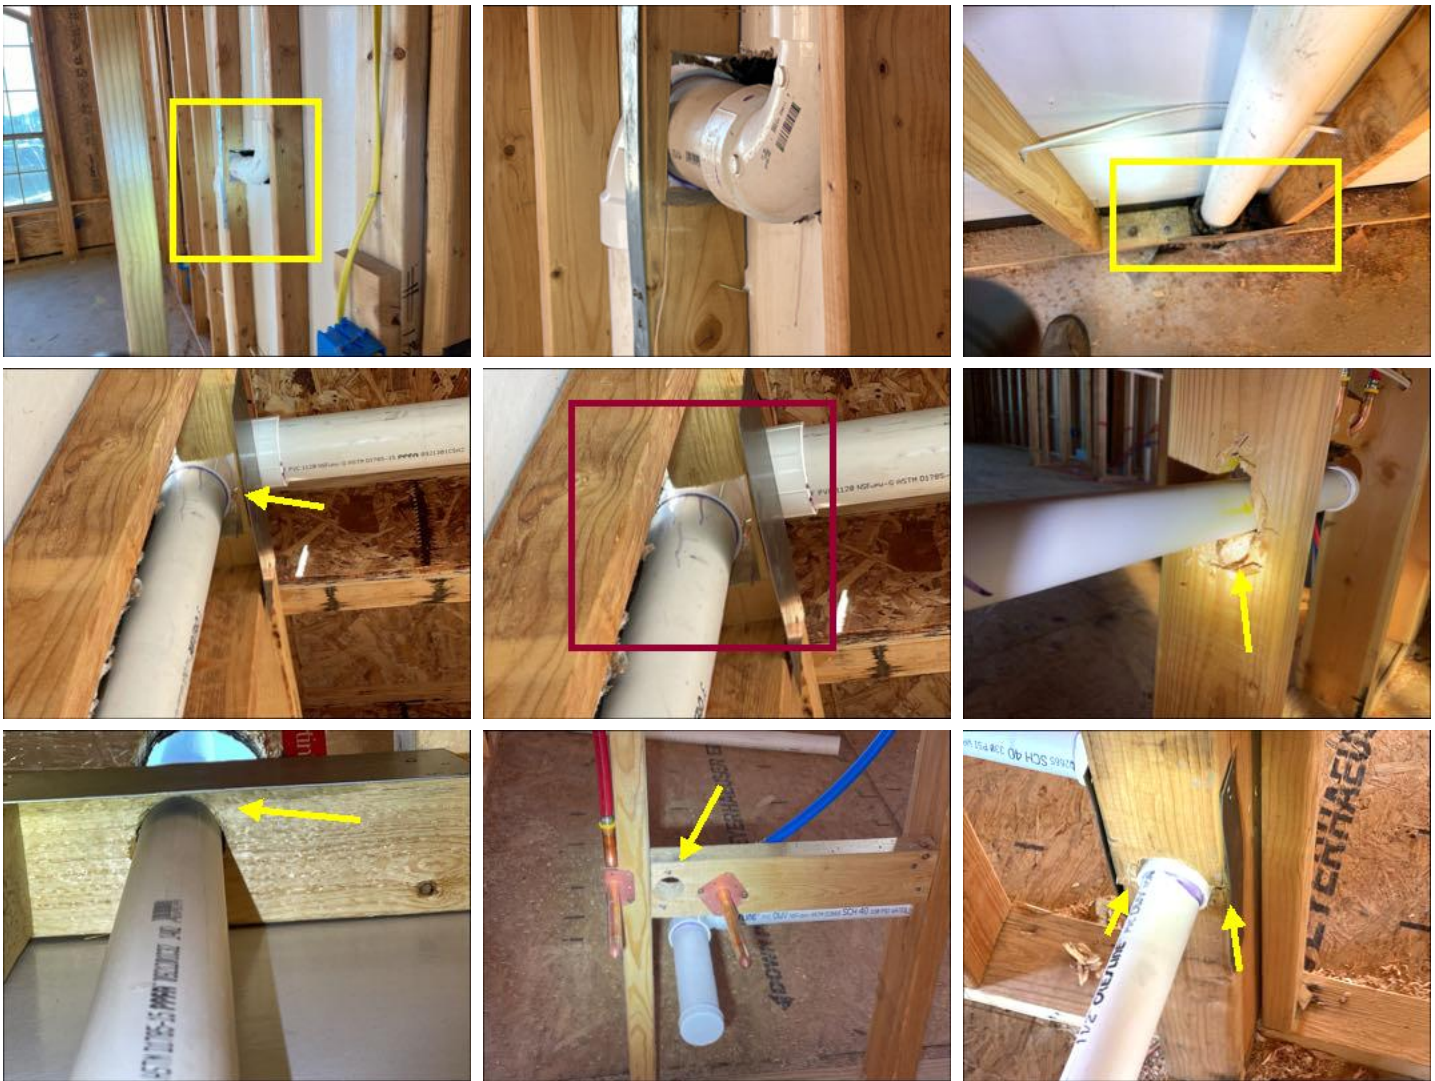
Covers missing for cleanouts. Recommend sewer scope prior to closing. Call 214-222-9208 to schedule.

Plumbing added in several places after framing and this appears to have compromised the framing members. Recommend review by structural engineer.

Chimney exhaust added by cutting wall stud. Recommend review by structural engineer.

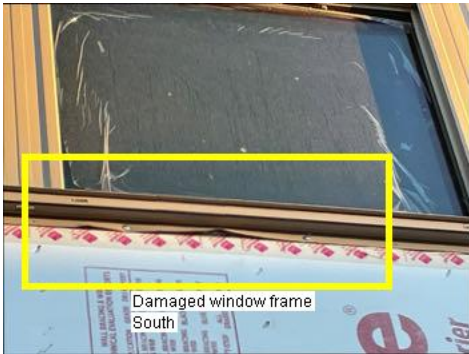
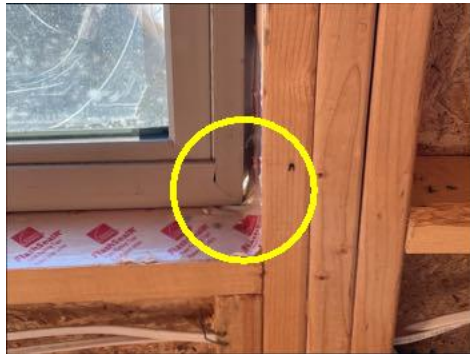
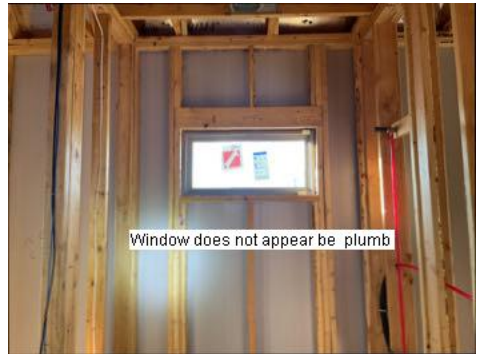
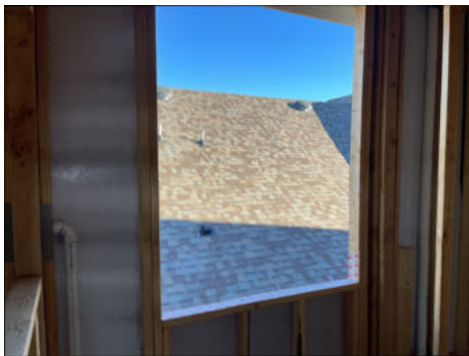
The installation of the dryer duct work was incomplete at the time of inspection. We recommend repair.

A cracked window was observed. We recommend having this replaced. This was noted in the Window missing upstairs.

Tape should be smooth throughout, extend beyond the frame and overlap so that water runs over it and out the weep holes.
